CONNECTICUT STATE REGISTER OF HISTORIC PLACES REGISTRATION FORM

historic name Stanley P. Rockwell Company Factory
 other names/site number _____

street & number 296 Homestead Avenue
 city or town Hartford vicinity
 county Hartford zip code 06112 not for publication

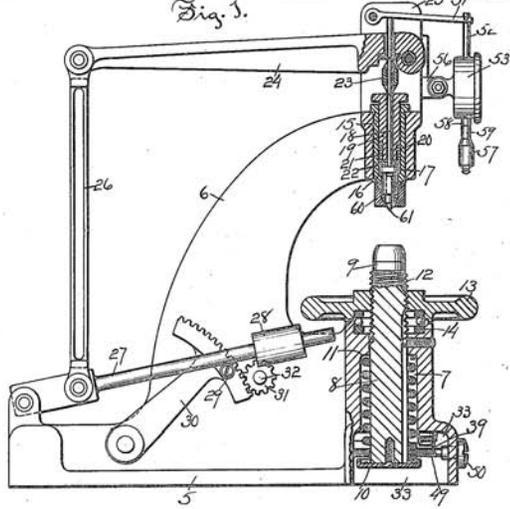
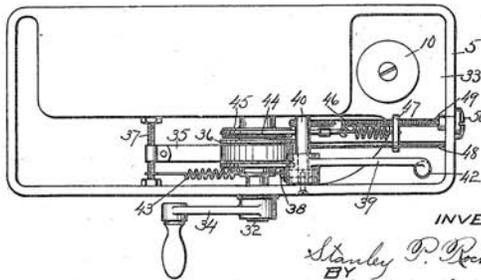
Image from the United States Patent number US1516208 for the S.P. Rockwell Hardness Testing Machine, awarded November 18, 1924.
Figure 4.

During the early 1910s, Stanley and Hugh Rockwell began developing designs for an improved hardness tester that could both provide quick results as well as be used on the curved surfaces of bearing race. Their design was based upon the principal of differential-depth measuring; this consisting of the application of minor and major loads as part of an indentation test. This process eliminated many of the errors associated with single-depth impact tests and the frequency with which these could result in inaccurate measurements due to backlash or surface roughness. The pair filed their first patent for the device on July 15, 1914, however, the patent (U.S. Patent No. 1,294,171) was not awarded until February 11, 1919, years after both Stanley and Hugh Rockwell had left they employ of New Departure.⁴

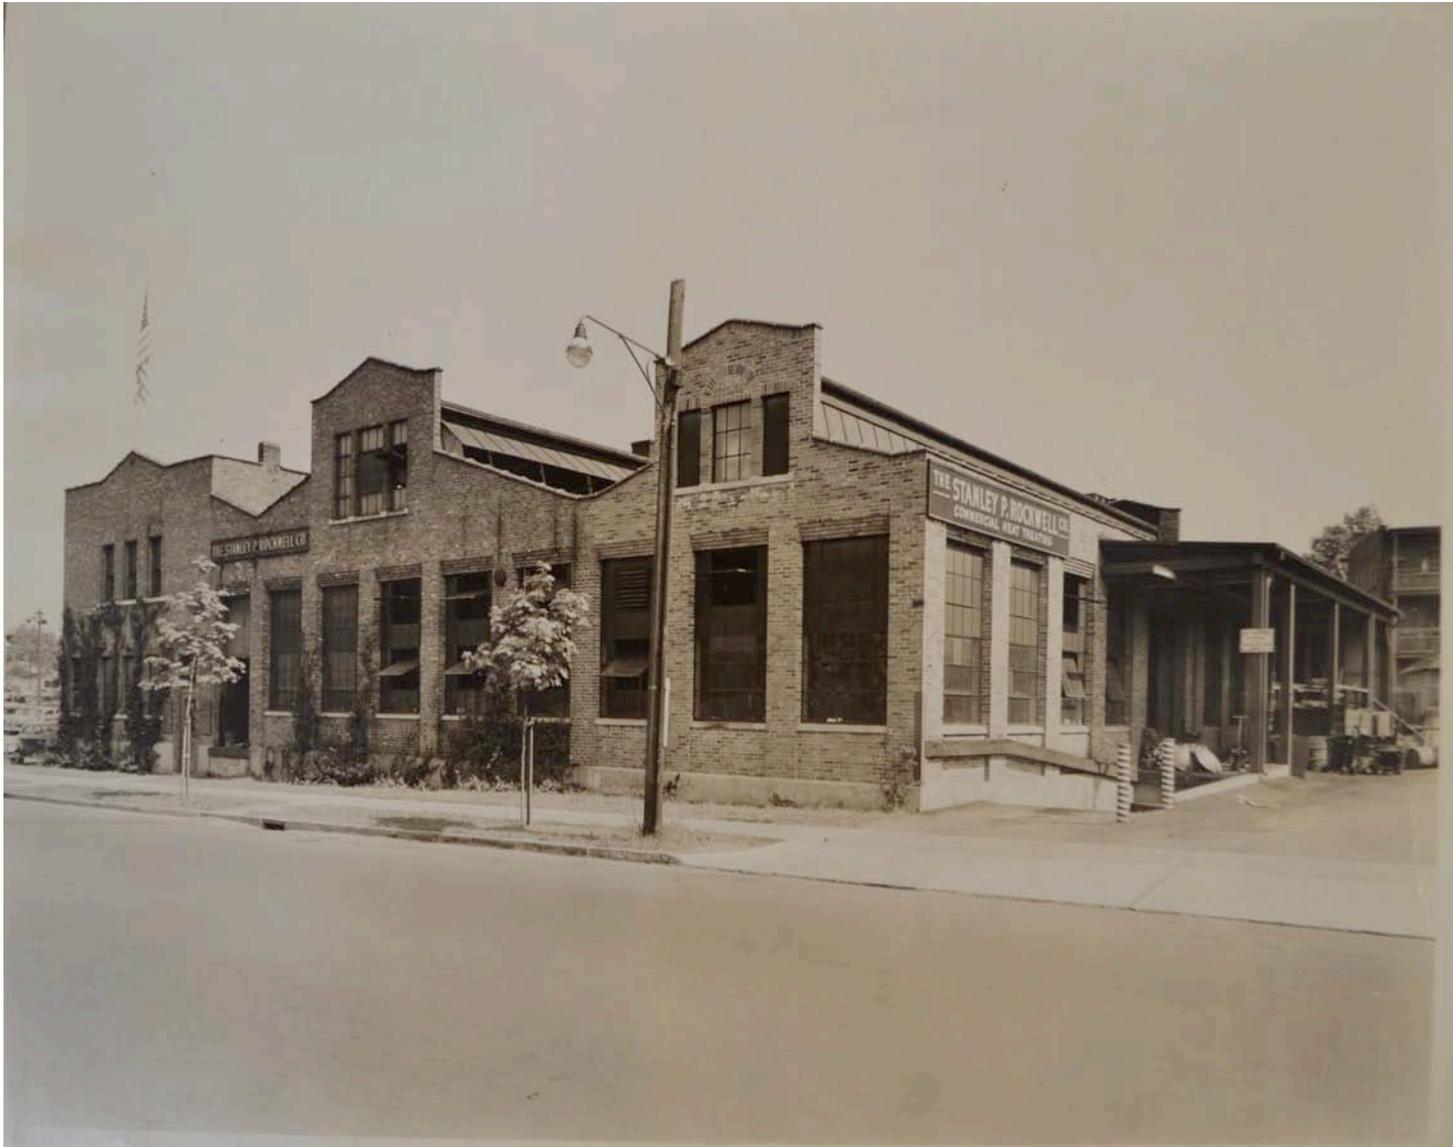
Historic photograph from ca. 1943 showing the then recently enlarged Stanley P. Rockwell Co. Factory.
Figure 6.

The original plant was enlarged in 1943 when a three-bay addition was erected adjoining the plant's east elevation (Figure 6). The details of the addition mimic those found in the original manufacturing block and include a concrete foundation, red brick piers and walls, large corbelled window bays with stone sills and multi-pane metal windows, a stepped brick parapet with soldier-coursed brick cornice and tile coping, and a front-facing pitched roof with a full-length clerestory monitor. A covered shipping and receiving area with a shed roof supported by square wood supports was built at the northern end of the addition's east elevation, however, this was enclosed and enlarged ca. 1970.

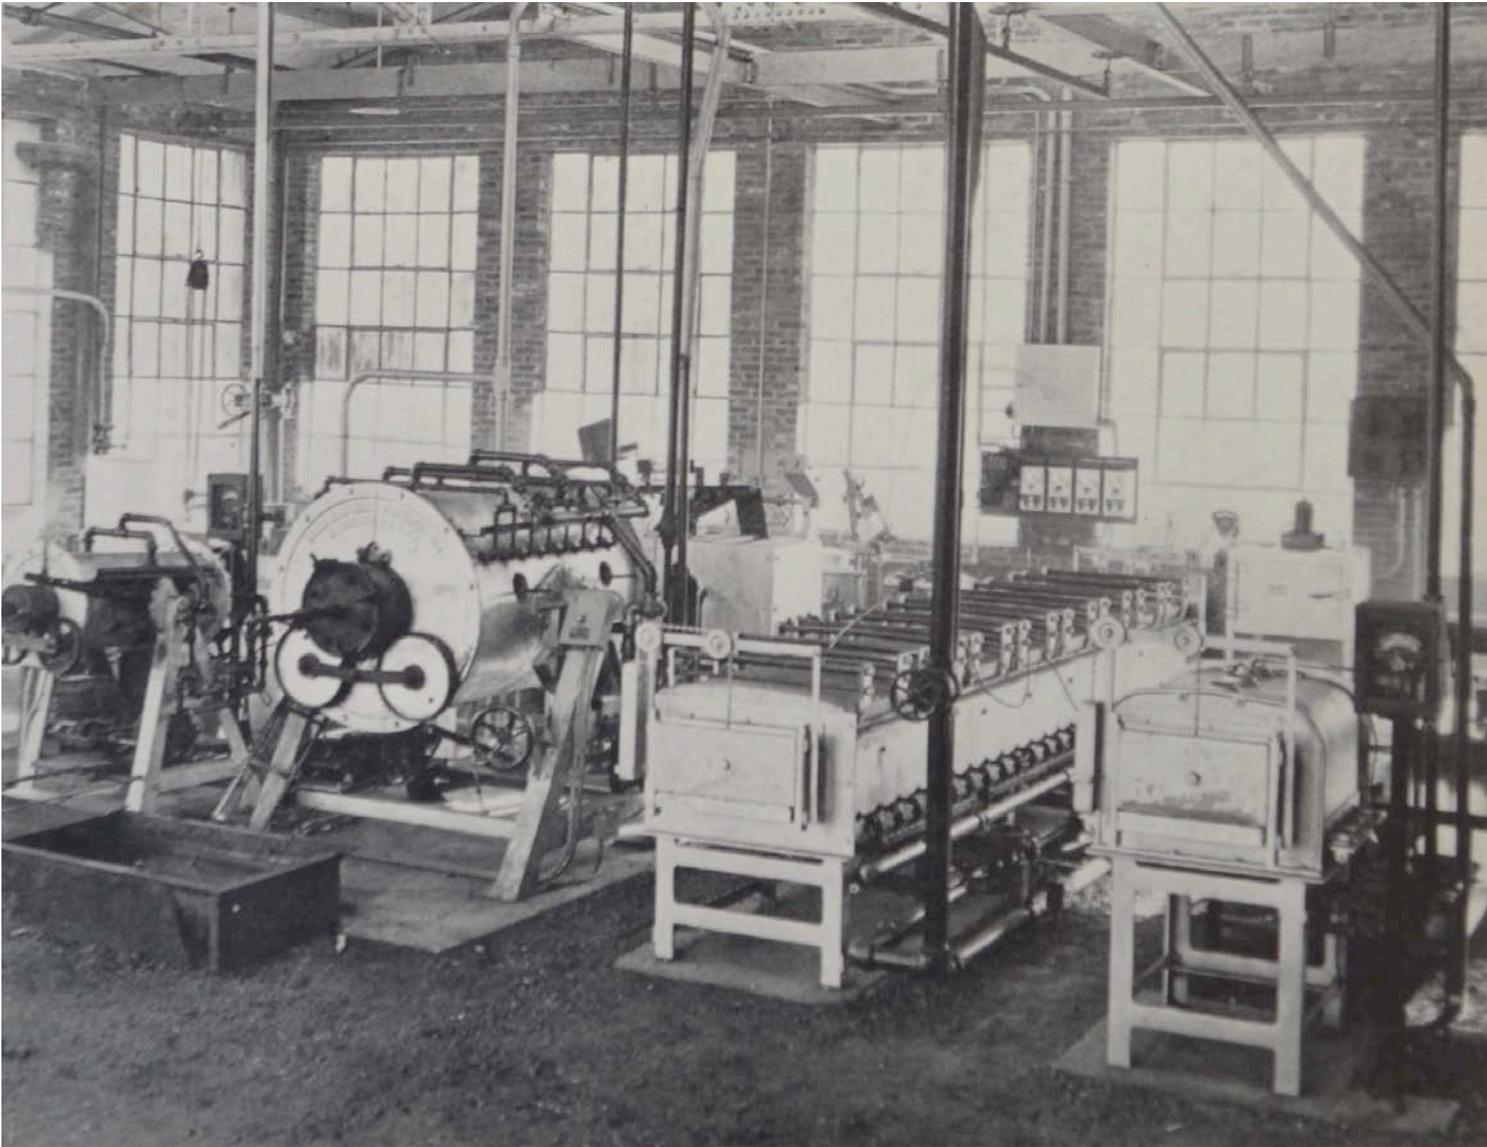
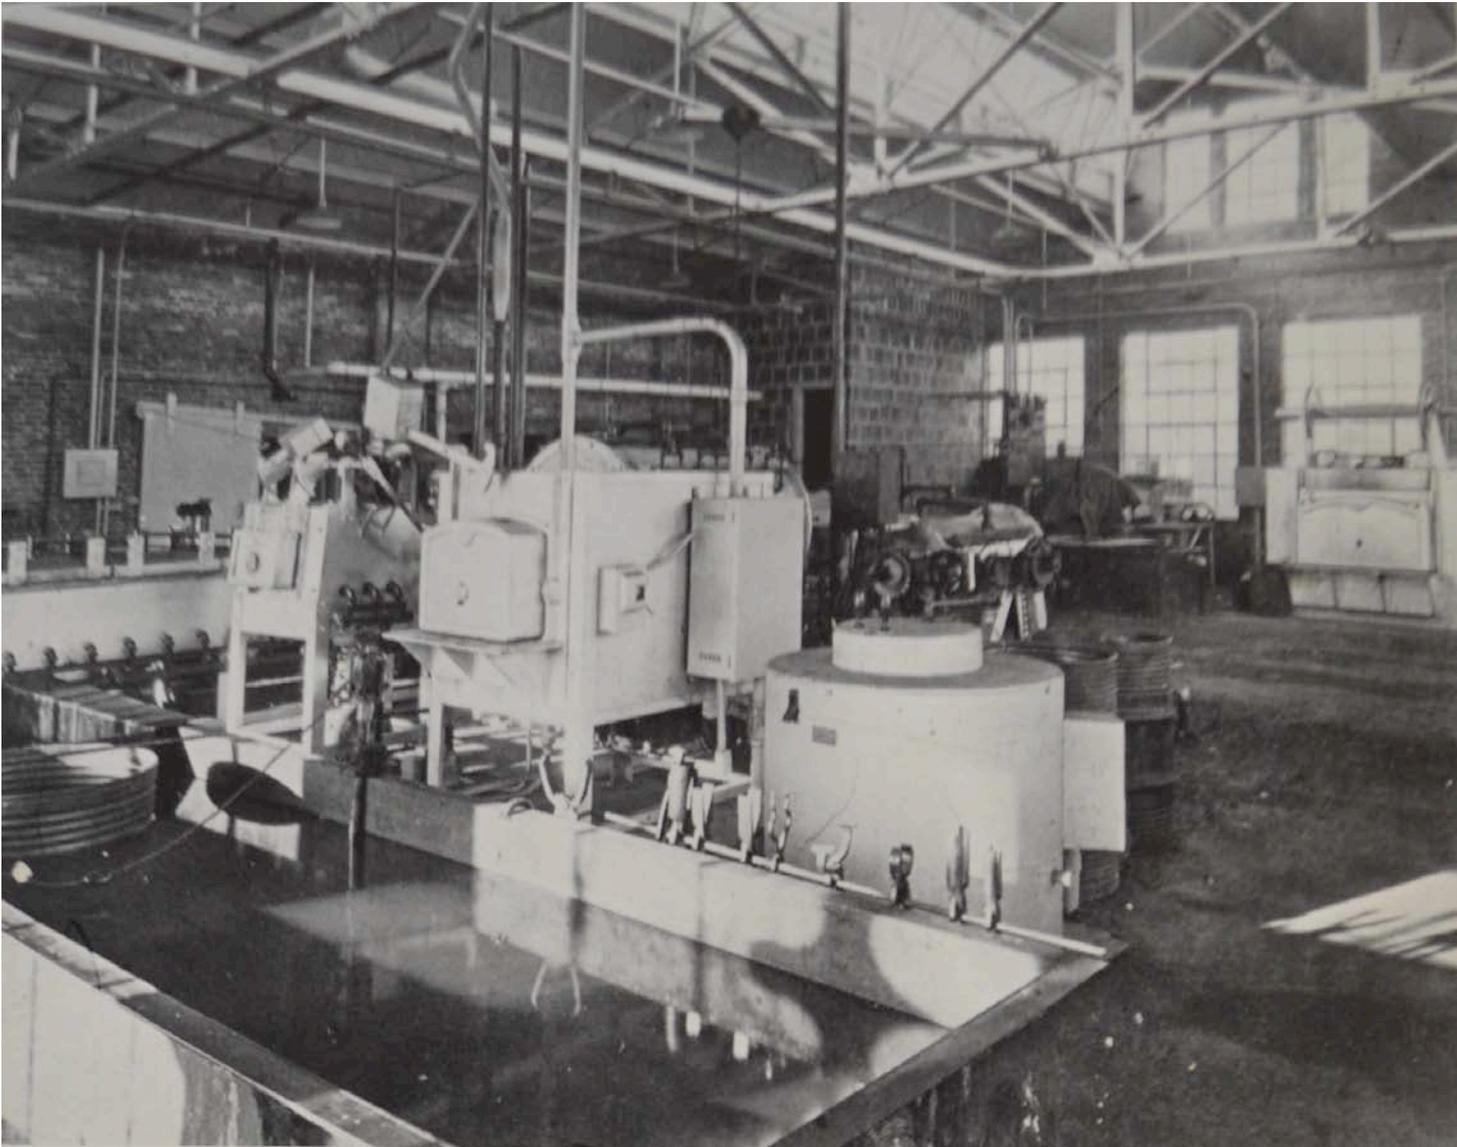
Historic photograph from 1929 showing various hardening equipment within the Stanley P. Rockwell Co. Factory.
Figure 7.

Historic photograph from 1929 showing various hardening equipment within the Stanley P. Rockwell Co. Factory.
Figure 8.

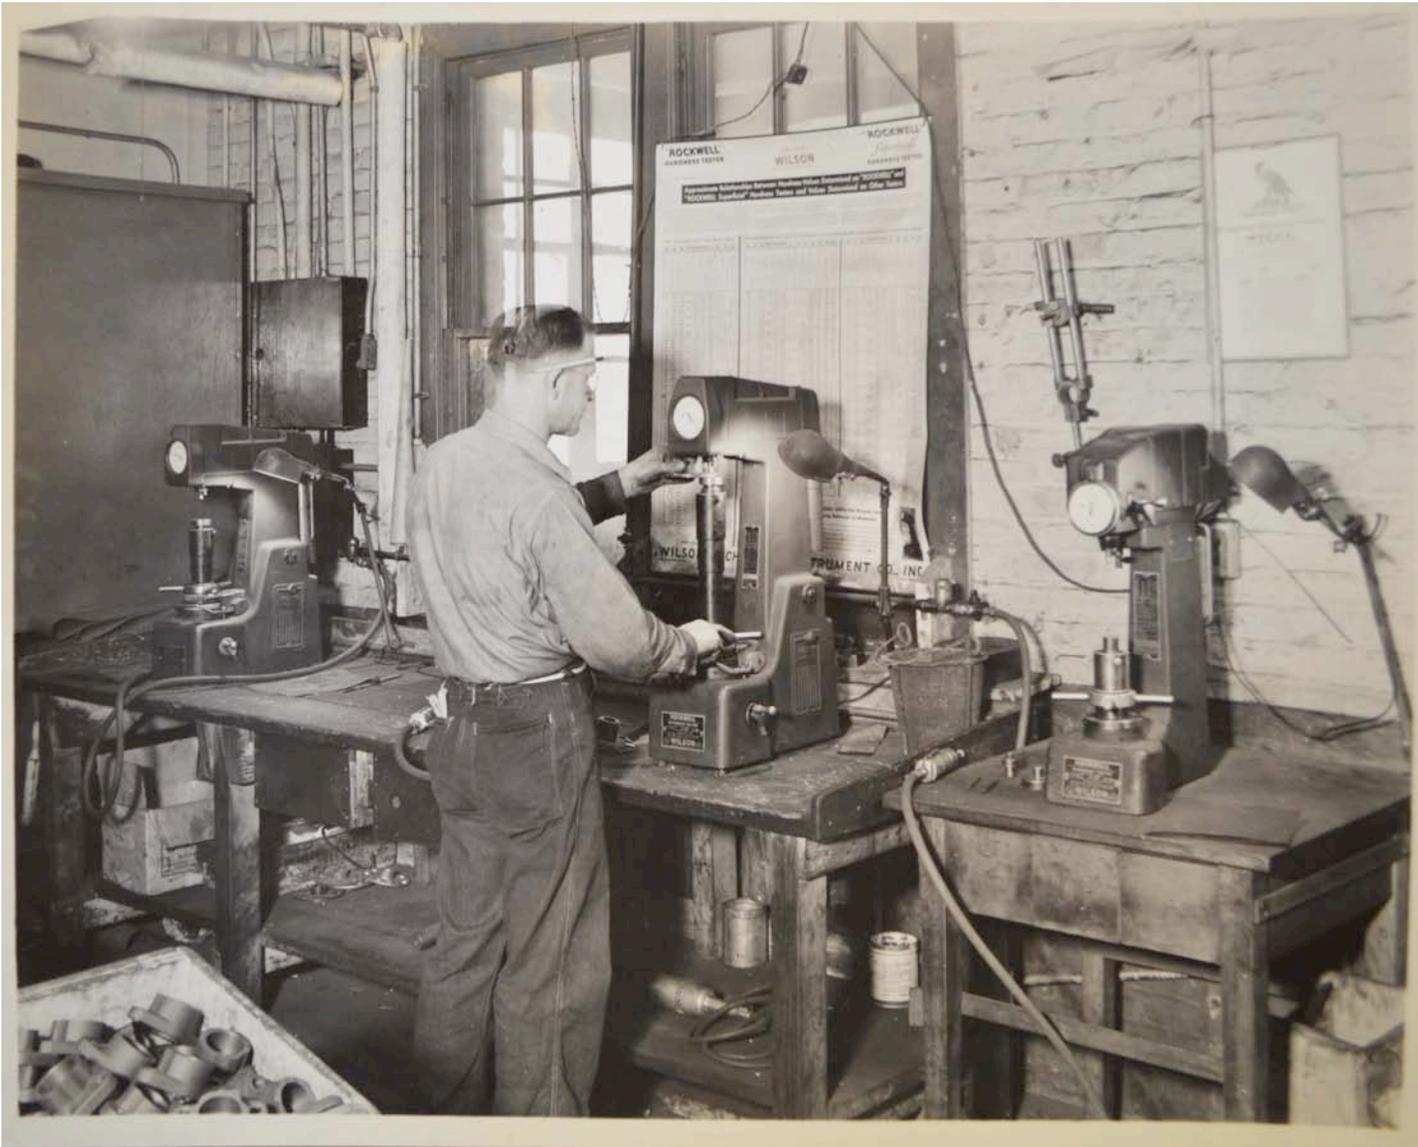
Historic photograph from 1968 showing a Stanley P. Rockwell Co. employee using a Rockwell Hardness Tester.
Figure 9.

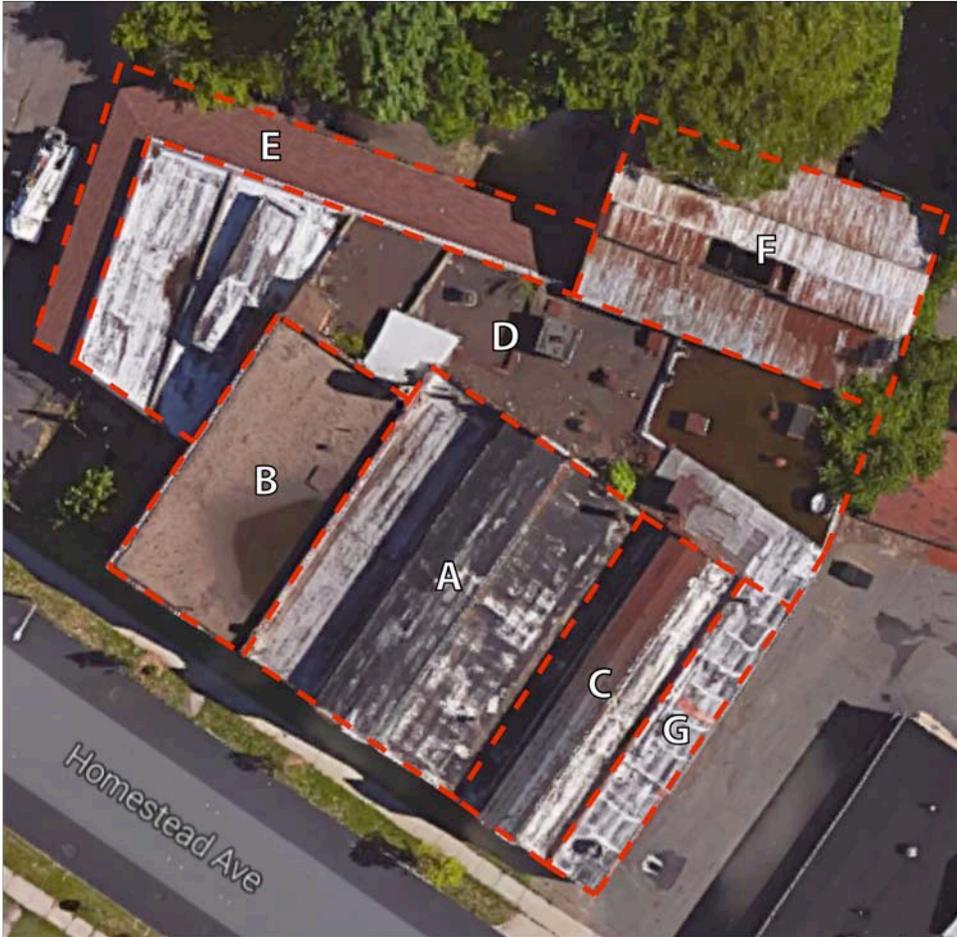
- A. Original Manufacturing Block, 1929.**
- B. Original office/laboratory block, 1929.**
- C. Manufacturing addition, 1943.**
- D. Shipping and storage block, ca. 1944/1946.**
- E. Loading dock, 1962.**
- F. Northeast addition, 1966.**
- G. East addition, 1929/ca. 1970.**

The Stanley P. Rockwell Company factory is a brick factory comprised of six adjoining one- to two-story red brick, concrete block, or wood-frame blocks (Photograph 1, Figure 12). The oldest portion of the plant was built in 1929. This consisted of the six-bay production shed with monitor roof at the center of the plant (as viewed from the façade (south elevation)), and the three-bay office and laboratory block located to the west (Figure 5). The one-and-a-half-story manufacturing building is of brick pier construction and has a concrete foundation, red brick walls, large corbelled window bays with stone sills and multi-pane metal windows, a stepped brick parapet with soldier-coursed brick cornice and tile coping, and a front-facing pitched roof with a full-length clerestory monitor. The office and laboratory is a two-story red brick block with a concrete foundation, a mix of round-arched and rectangular window openings with detailed brick surrounds and stone sills, six-over-six double-hung wood windows, a gabled brick parapet with a soldier-coursed brick cornice and tile coping, and a flat roof.

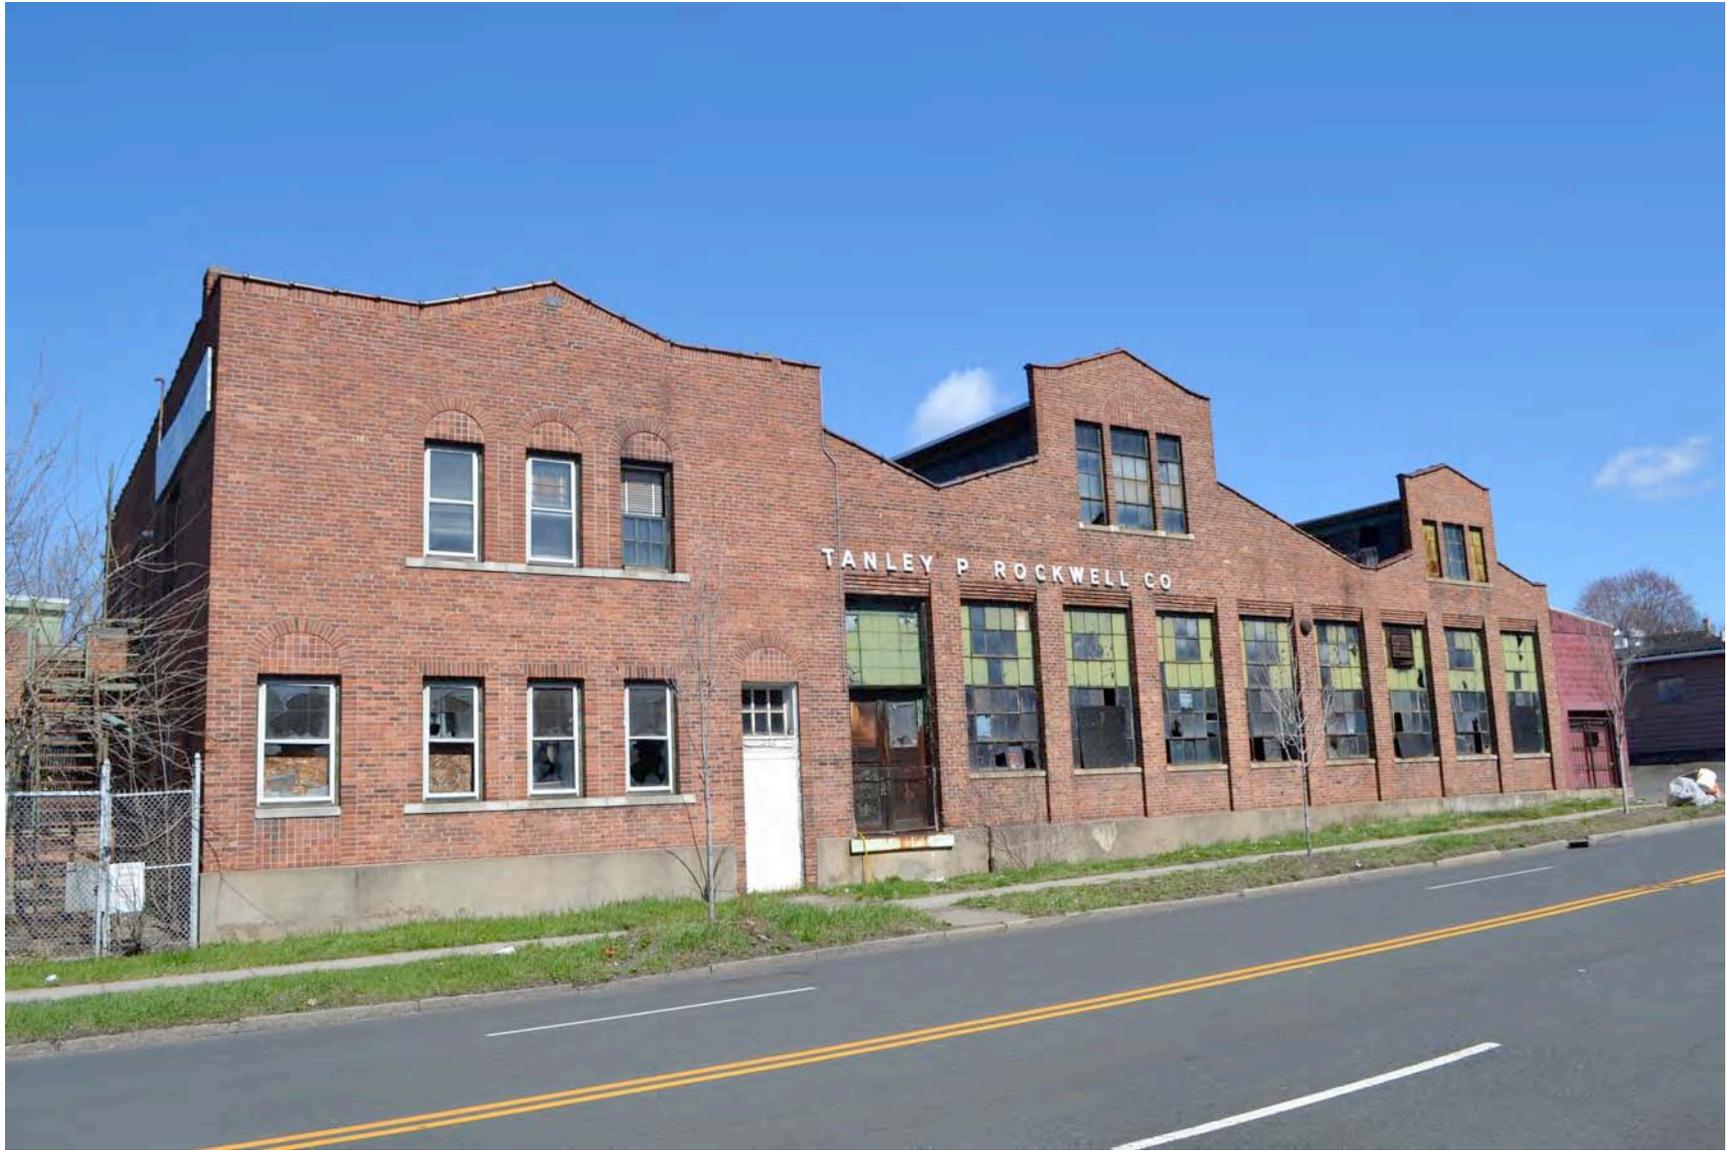
**Façade (south elevation) of the Stanley P. Rockwell Company factory, 1929, ca. 1970.
Camera facing east. Photograph 1 of 23.**

In the upper section of the façade, a stepped brick parapet with soldier-coursed brick cornices and tile coping traces the outline of the paired front-facing gable roofs and two six-foot-tall clerestory monitors run the full depth of the original block. Tripartite windows are located in the block's two gable ends, these allowing additional light into the plant

via the south side of the monitors. The tripartite windows have stone sills and are framed by brick trim, this forming a round-arched fan above each of the central windows. The interior of the fan is filled with rectangular bricks forming a grid pattern. Fenestration in the manufacturing block's western gable-end consists of multipane metal sash with pivot-style openings, while that in the eastern gable-end consists of fixed multipane metal sash.

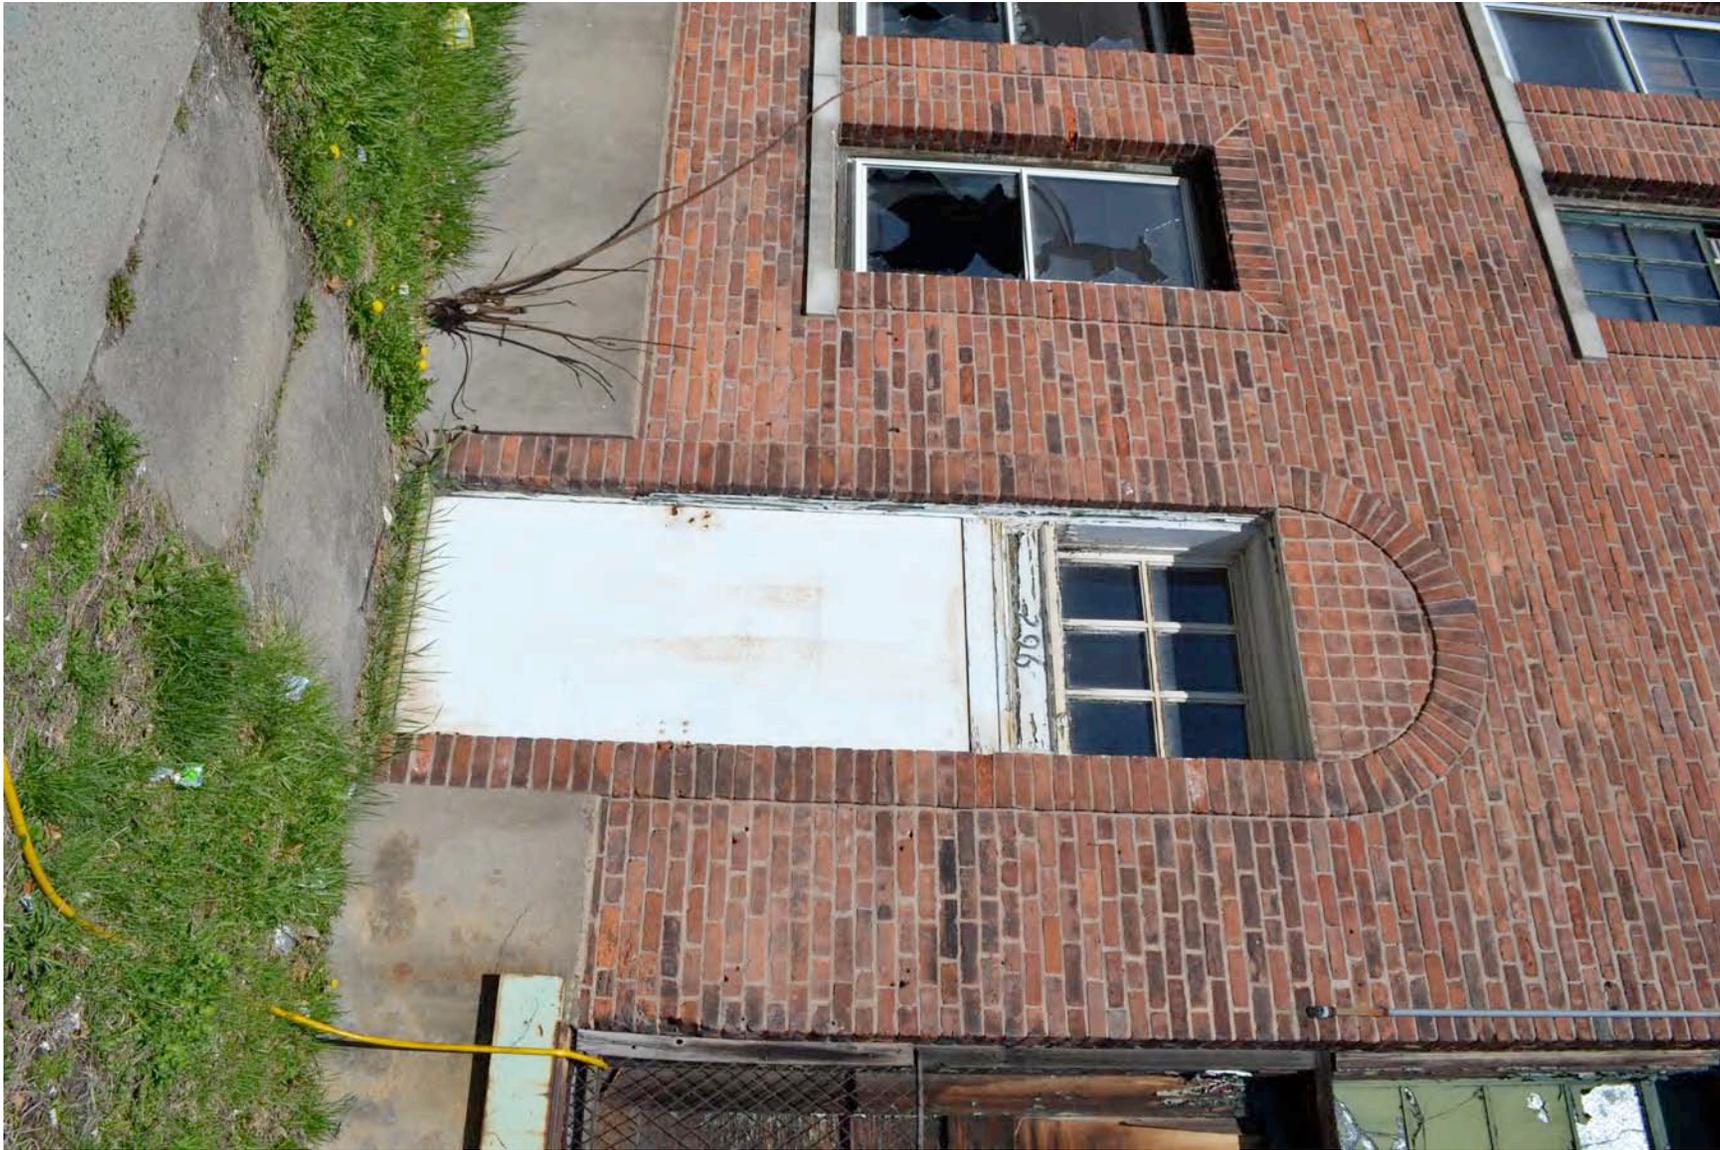
Façade (south elevation) of the Stanley P. Rockwell Company factory, 1929. Showing loading bay details.
Camera facing northeast. Photograph 2 of 23.

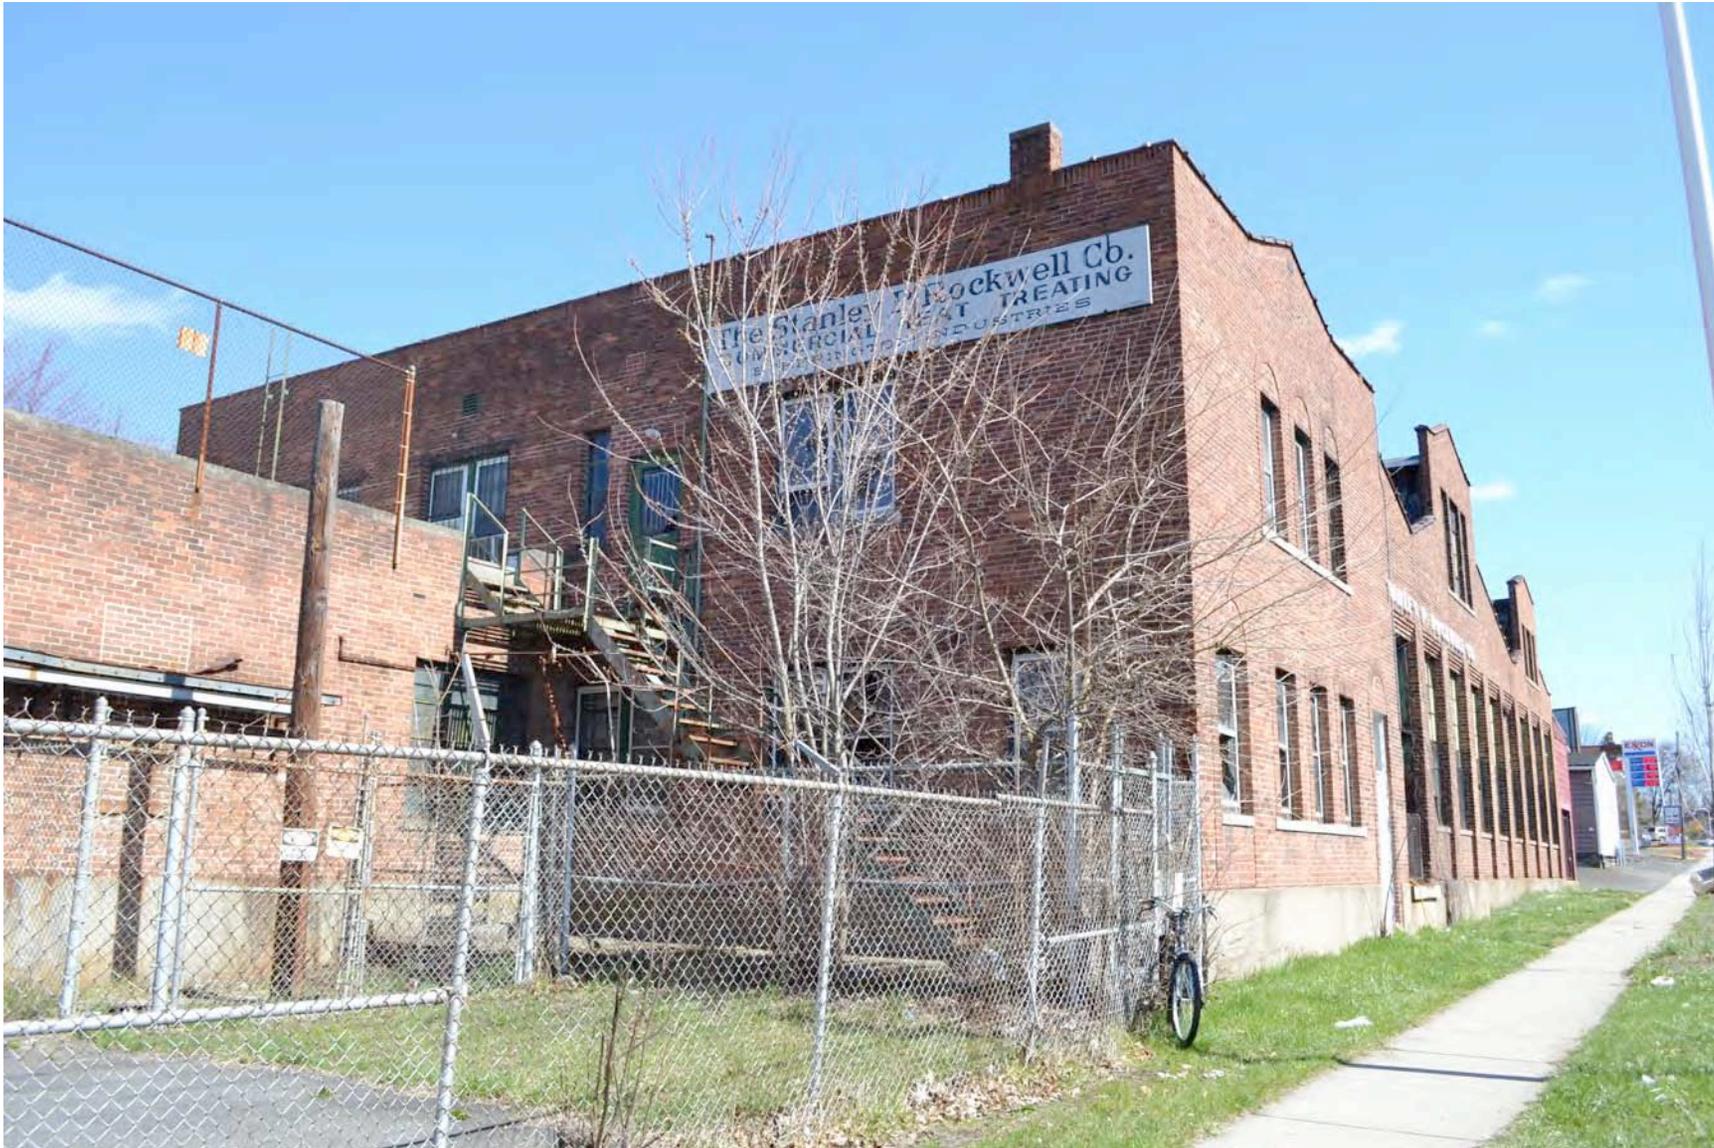
**West and south elevations of the Stanley P. Rockwell Company factory, 1929, ca. 1940.
Camera facing northeast. Photograph 4 of 23.**

The west (side) elevation of the office and laboratory block lacks the detailing found on the façade (Photograph 4). Window openings are found on both the first and second stories of the elevation, these being of both single and paired arrangements. The windows are set in plain rectangular brick openings and they have concrete sills and primarily six-over-six double-hung wood sash. A metal fire escape leads to a pass-through door located near the center of the elevation on the second floor. The door is a paneled metal unit with a large rectangular light in its upper half. A tall, narrow window opening flanks the north side of the entry. This has a concrete sill and four vertically oriented fixed lights.

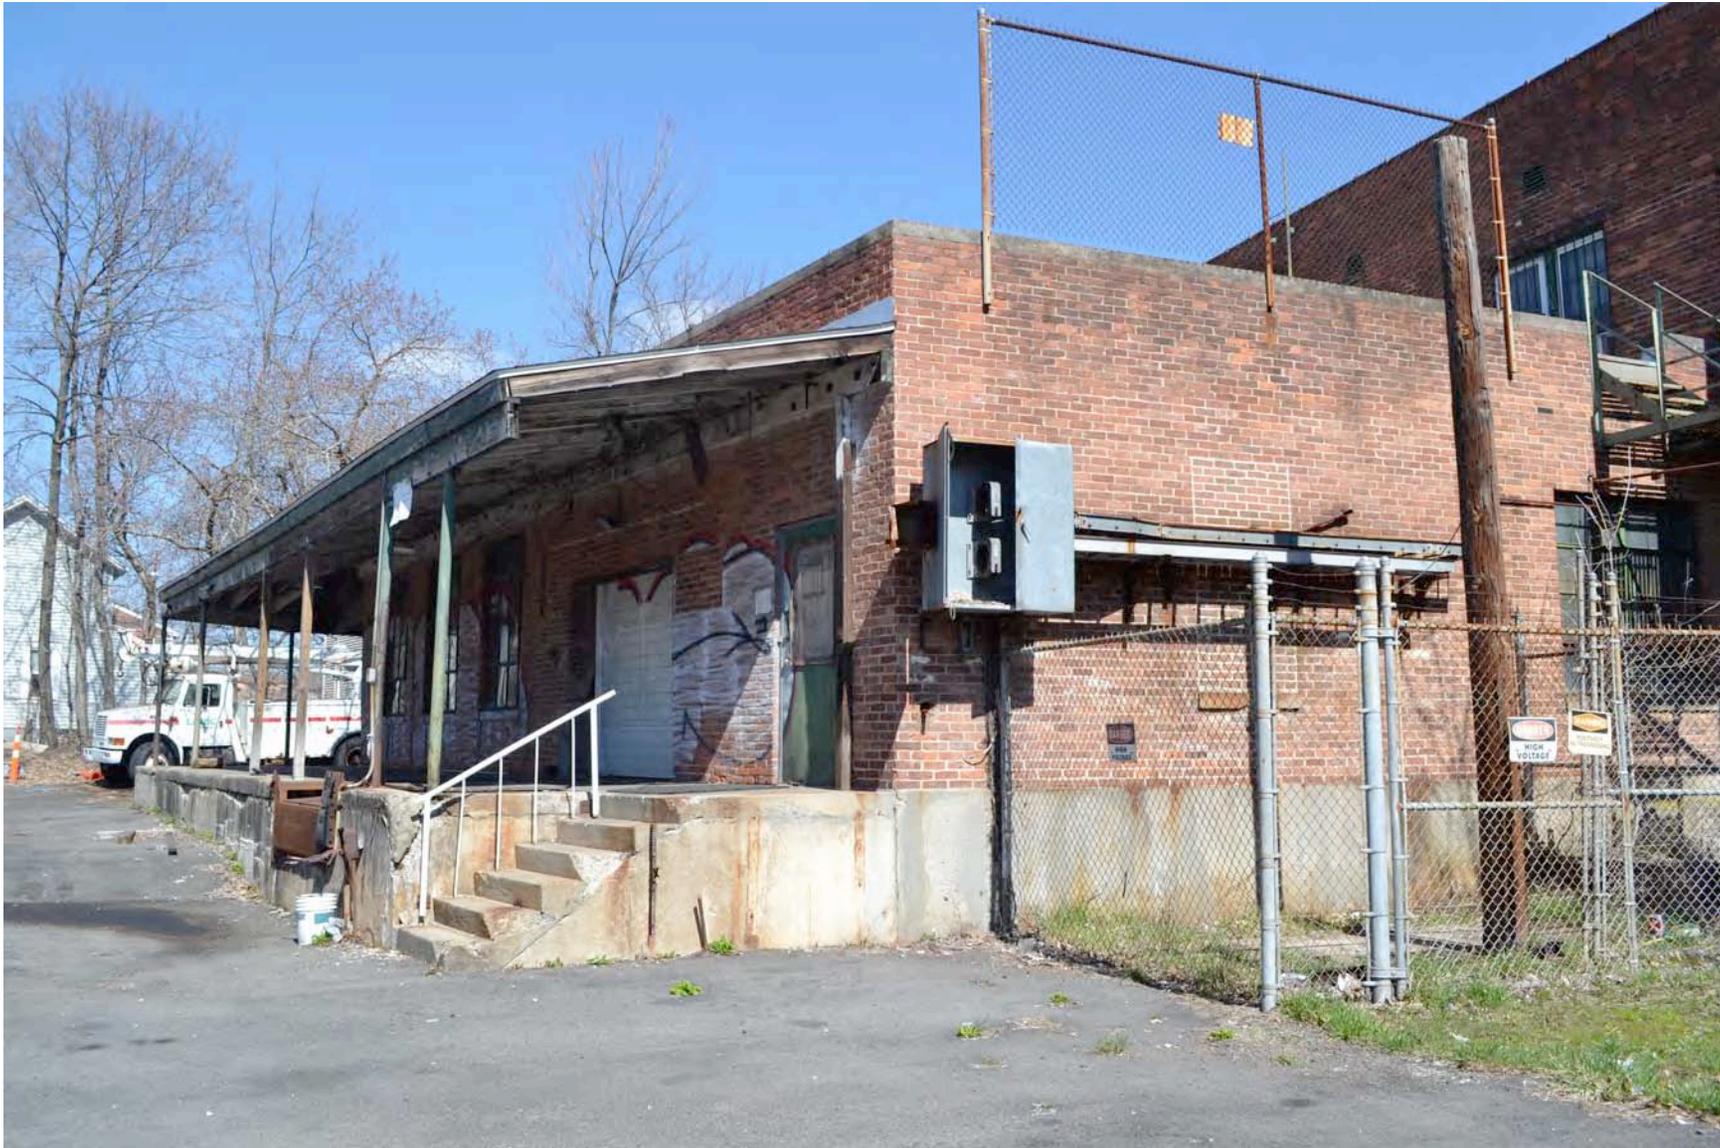
West and south elevations of the Stanley P. Rockwell Company factory, 1929, ca. 1940. Note details of ca. 1940 addition. Camera facing northeast. Photograph 5 of 23.

A one-story red brick shipping and storage addition adjoins the original building's west and north elevations (Photographs 5 & 6). Erected between ca. 1944 and 1946, the addition wraps around the northwest corner of the office/laboratory block and extends across the entire north (rear) elevation of the factory. The shipping and storage block stands on a tall concrete foundation that was extended beyond the exterior walls in 1962 to form a loading dock on the west and north sides of the block. The loading dock is sheltered by a flat-roofed porch supported by narrow steel columns. The shipping and storage block has red brick apron walls, large rectangular window openings with concrete sills, concrete coping, and a flat roof with a clerestory monitor. The windows consist of multipane metal sash with central pivot openings. A concrete stair leads onto the southern end of the loading dock. At the top of the stairs, a metal pass-through door with a large rectangular light provides access to the southern end of the addition's west elevation. A loading bay with a roll-up metal door is located roughly ten feet north of the pass-through door.

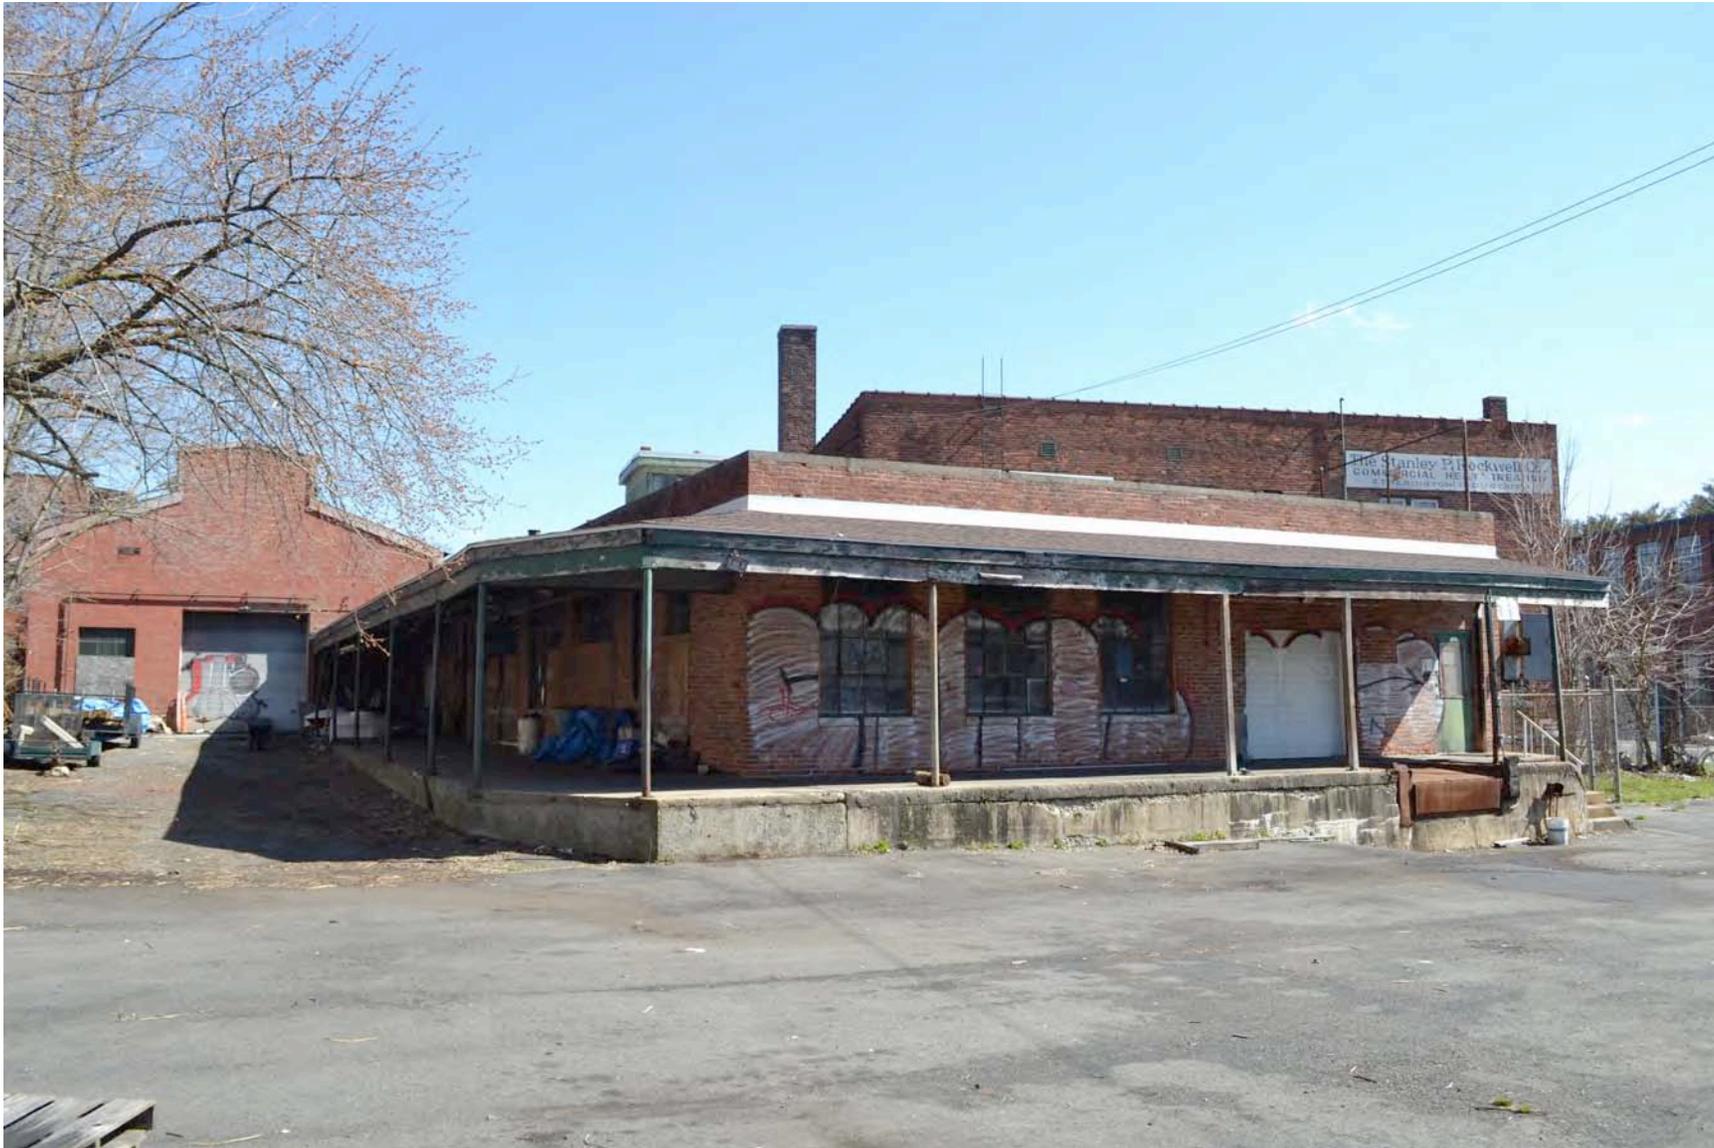
West and north elevations of the Stanley P. Rockwell Company factory, 1929, ca. 1940, ca. 1970. Note details of ca. 1940 and ca. 1970 additions.

Camera facing southeast. Photograph 6 of 23.

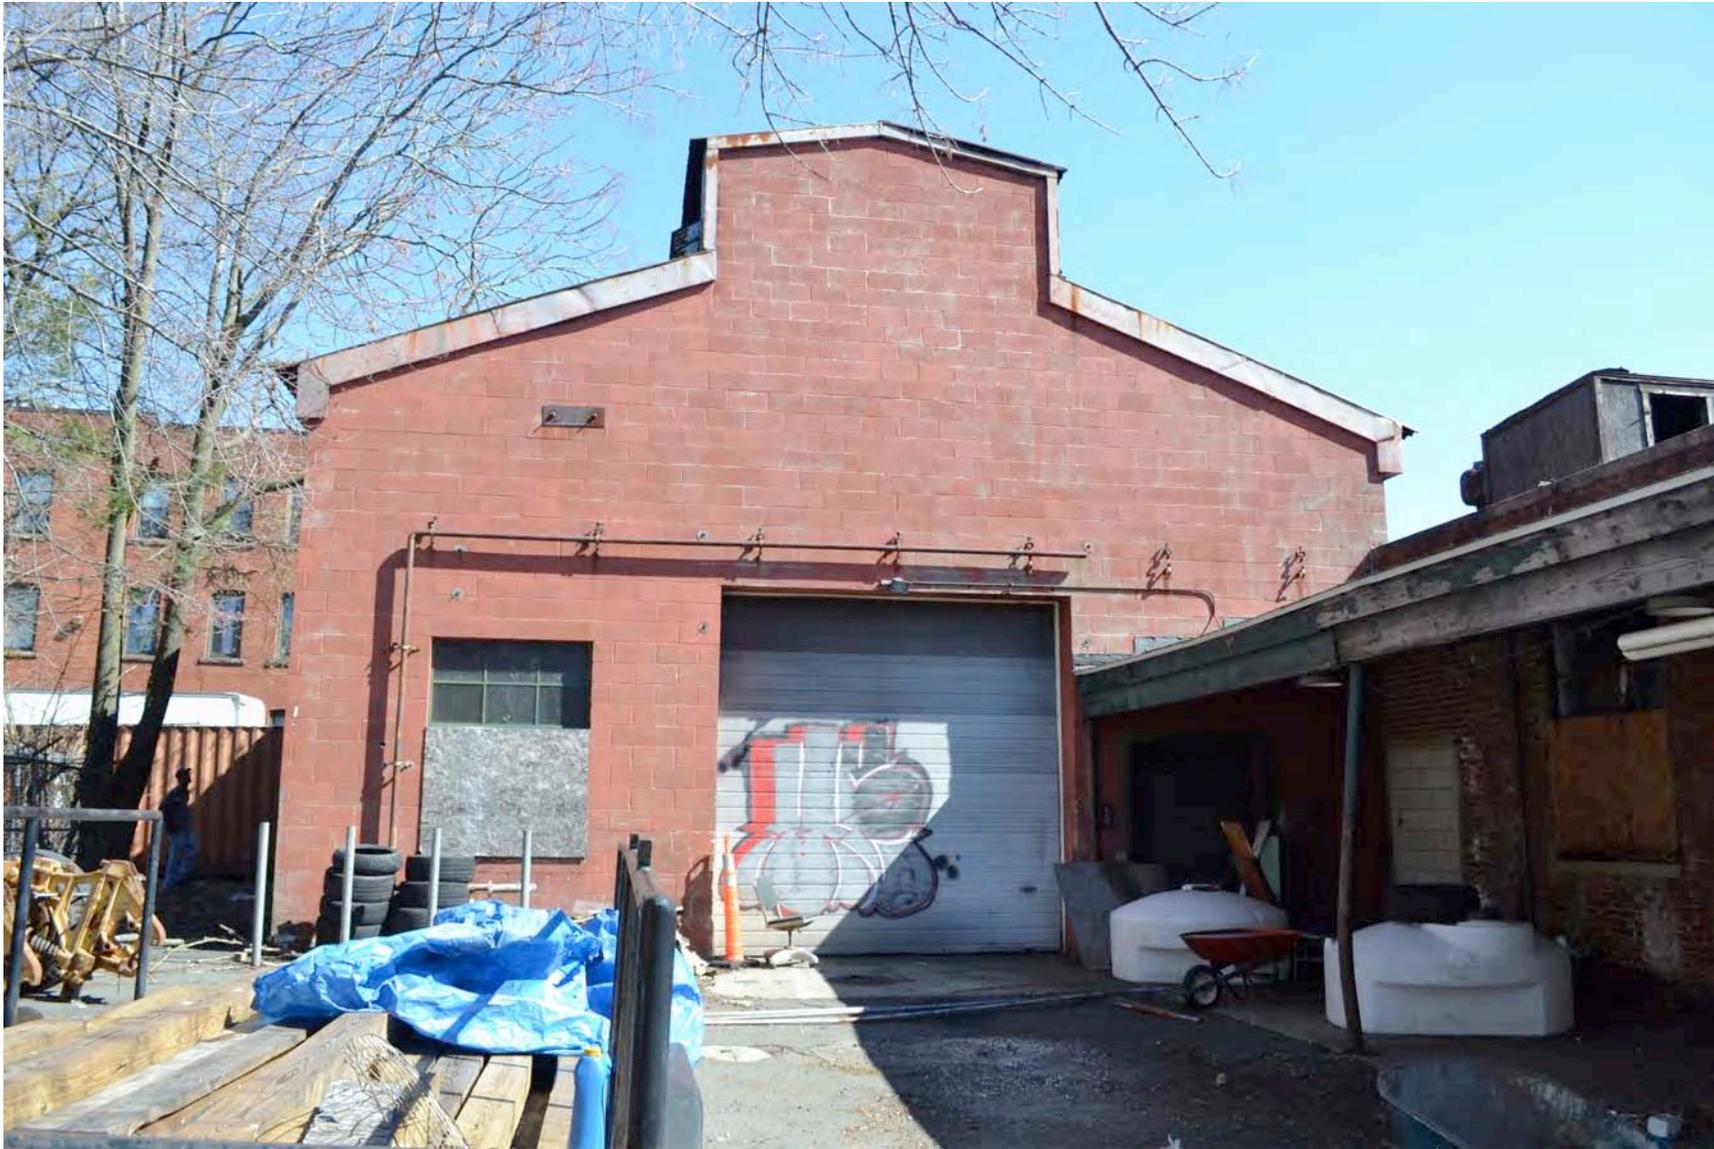
West and north elevations of the Stanley P. Rockwell Company factory, ca. 1940, ca. 1970. Note details of ca. 1970 addition. Camera facing southeast. Photograph 7 of 23.

A one-and-a-half-story, 64-foot by 40-foot addition adjoins the northeast corner of the ca. 1944/1946 block (Photograph 7). Built in 1966, the northeast addition is of concrete block construction and has a concrete foundation and a front-facing gable roof with a gabled clerestory monitor. The only openings in the block's exterior walls are located on the west (façade) elevation. Here there is a large central loading bay flanked to the south by a smaller loading bay, and to the north by a single window opening. Both of the loading bays have roll-up metal doors, while the window has multipane metal sash with a pivot opening.
