CONNECTICUT STATE REGISTER OF HISTORIC PLACES REGISTRATION FORM

historic name Stanley P. Rockwell Company Factory
 other names/site number _____

street & number 296 Homestead Avenue
 city or town Hartford vicinity
 county Hartford zip code 06112 not for publication

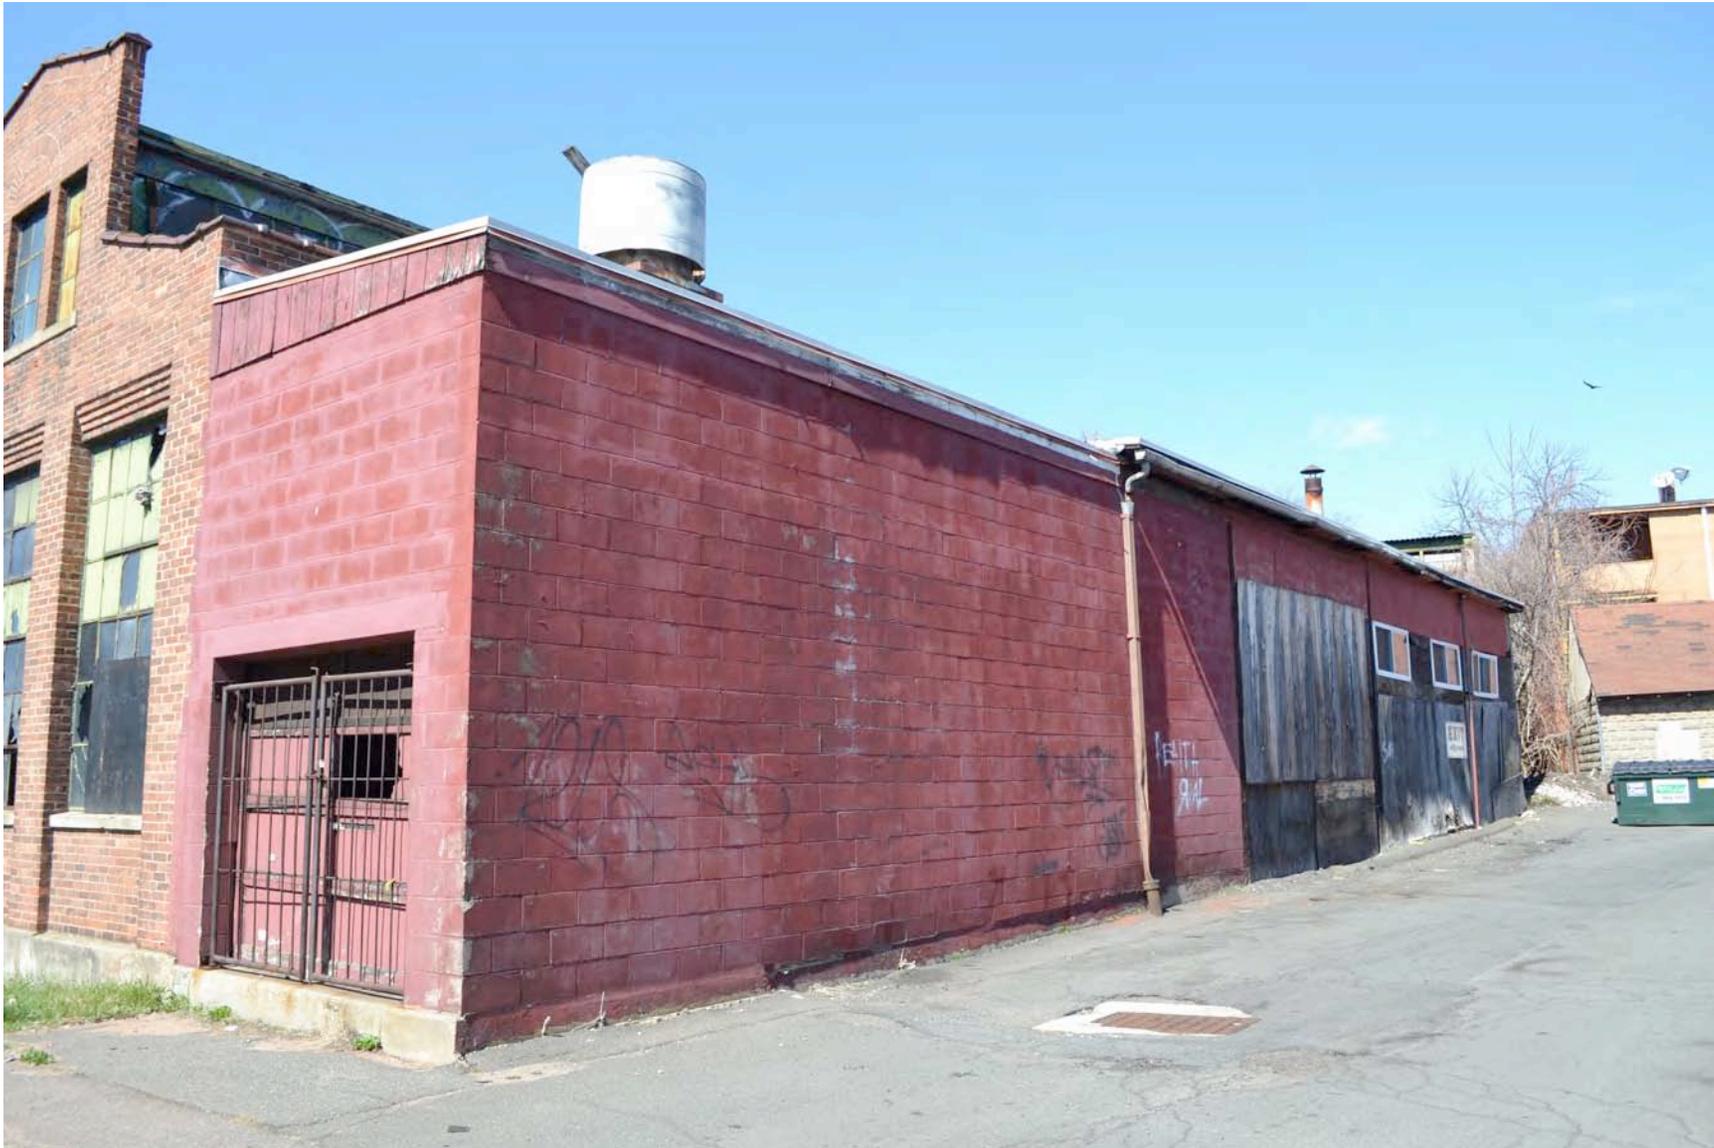
East and north elevations of the Stanley P. Rockwell Company factory, 1929, ca. 1970. Note details of ca. 1970 addition. Camera facing north. Photograph 8 of 23.

The south elevation of the factory is spanned by a one-story wood-frame and concrete block addition with a shed roof. (Photograph 8). The northern half of the block was erected as a wood-frame shed-roof porch in 1943, however, this was enclosed with plywood sheathing and enlarged via the construction of a concrete block addition adjoining its south side around 1970. The resultant addition stands on a concrete foundation and measures roughly 13 feet by 85 feet. It has a garage type door opening with a wood roll-up door on its south elevation, and three small rectangular window openings set in a wood-frame section of the northern end of the block's east elevation.

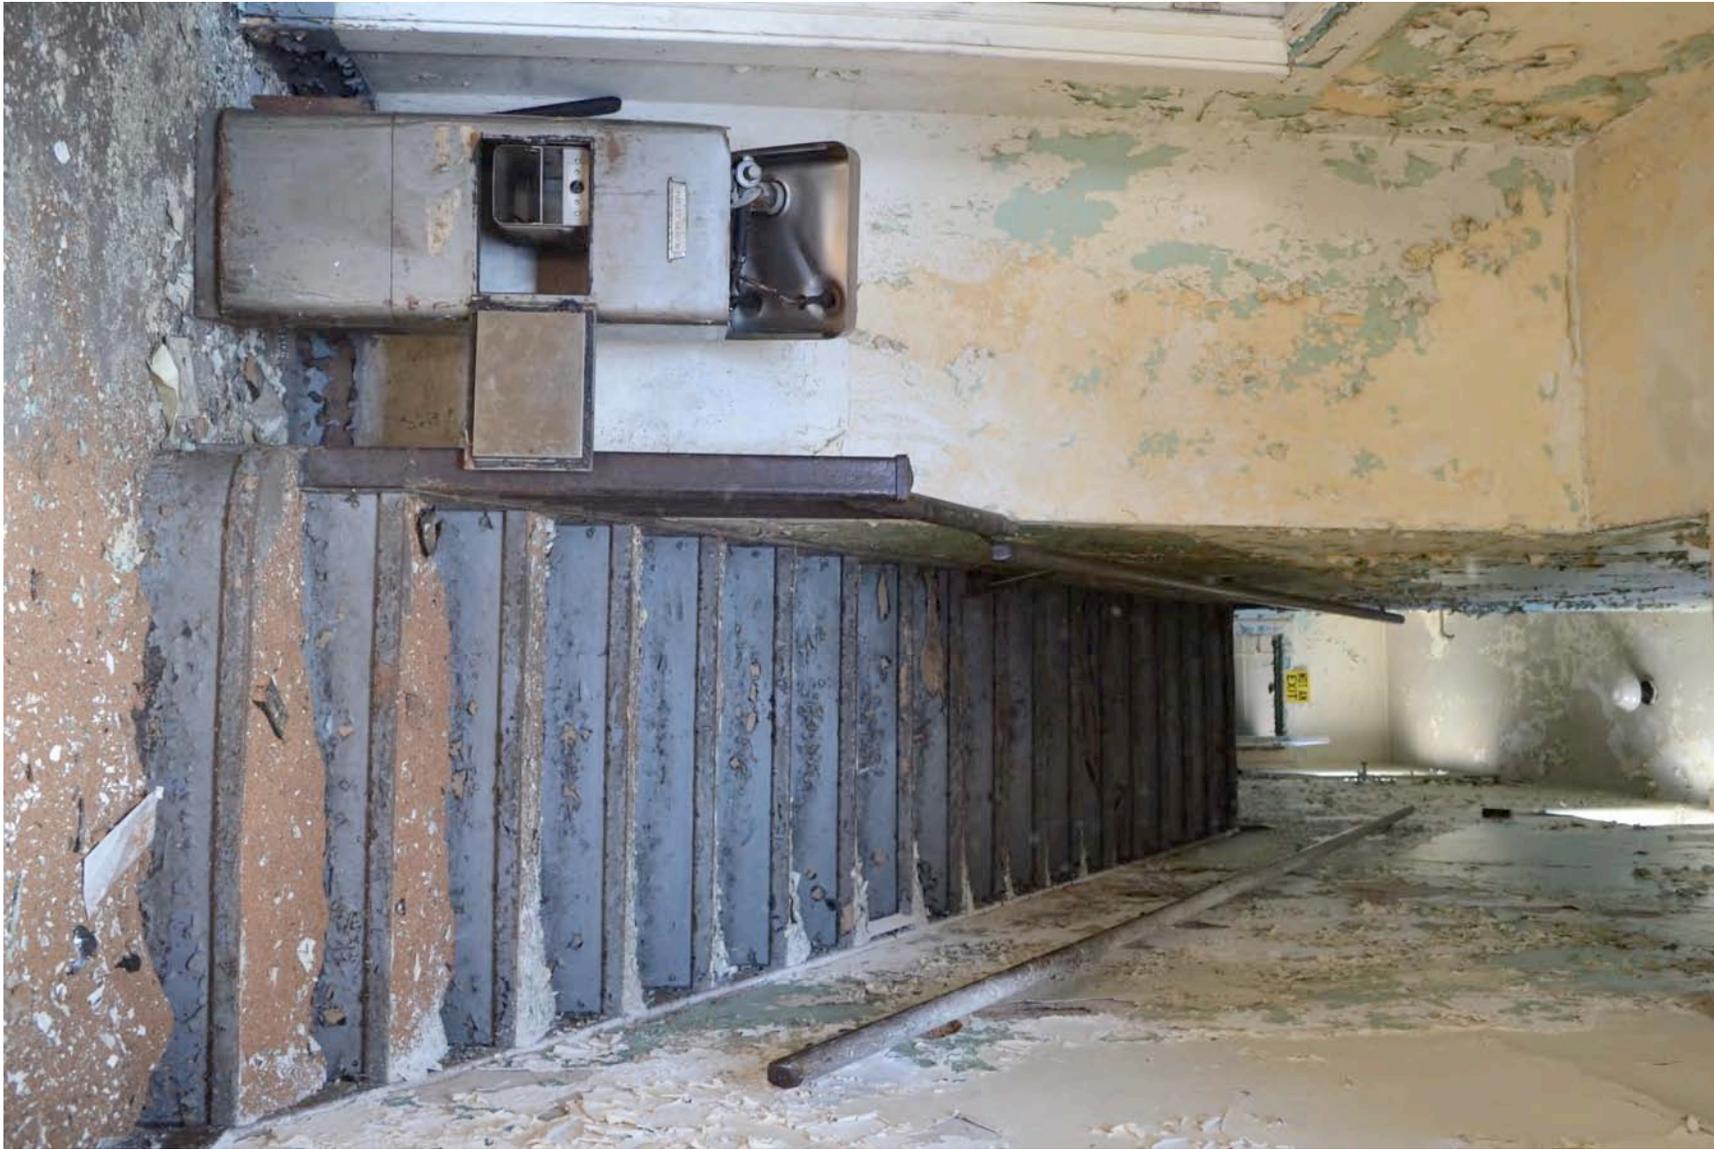
Interior of the Stanley P. Rockwell Company factory. Note details of stair leading to the second floor of the office/laboratory building. Camera facing northeast. Photograph 10 of 23.

The interior floorplan of the Stanley P. Rockwell Company factory consists of largely open areas that roughly correspond with each of the primary blocks. Only the office/laboratory building is subdivided into numerous smaller spaces, as several offices and a stairwell are found on the first floor, and additional offices and lavatories are located on the second floor. The primary entrance to the factory leads into a small vestibule at the southeast corner of the office/laboratory building (Photograph 9). The space has a concrete floor, plain wood mopboards, and a plaster ceiling and walls. Plain wood trim frames both the interior side of the entrance and a door opening leading northwest into the block. A single-run iron stair with a square iron newel post and round wood rails leads to the second floor of the building (Photograph 10).

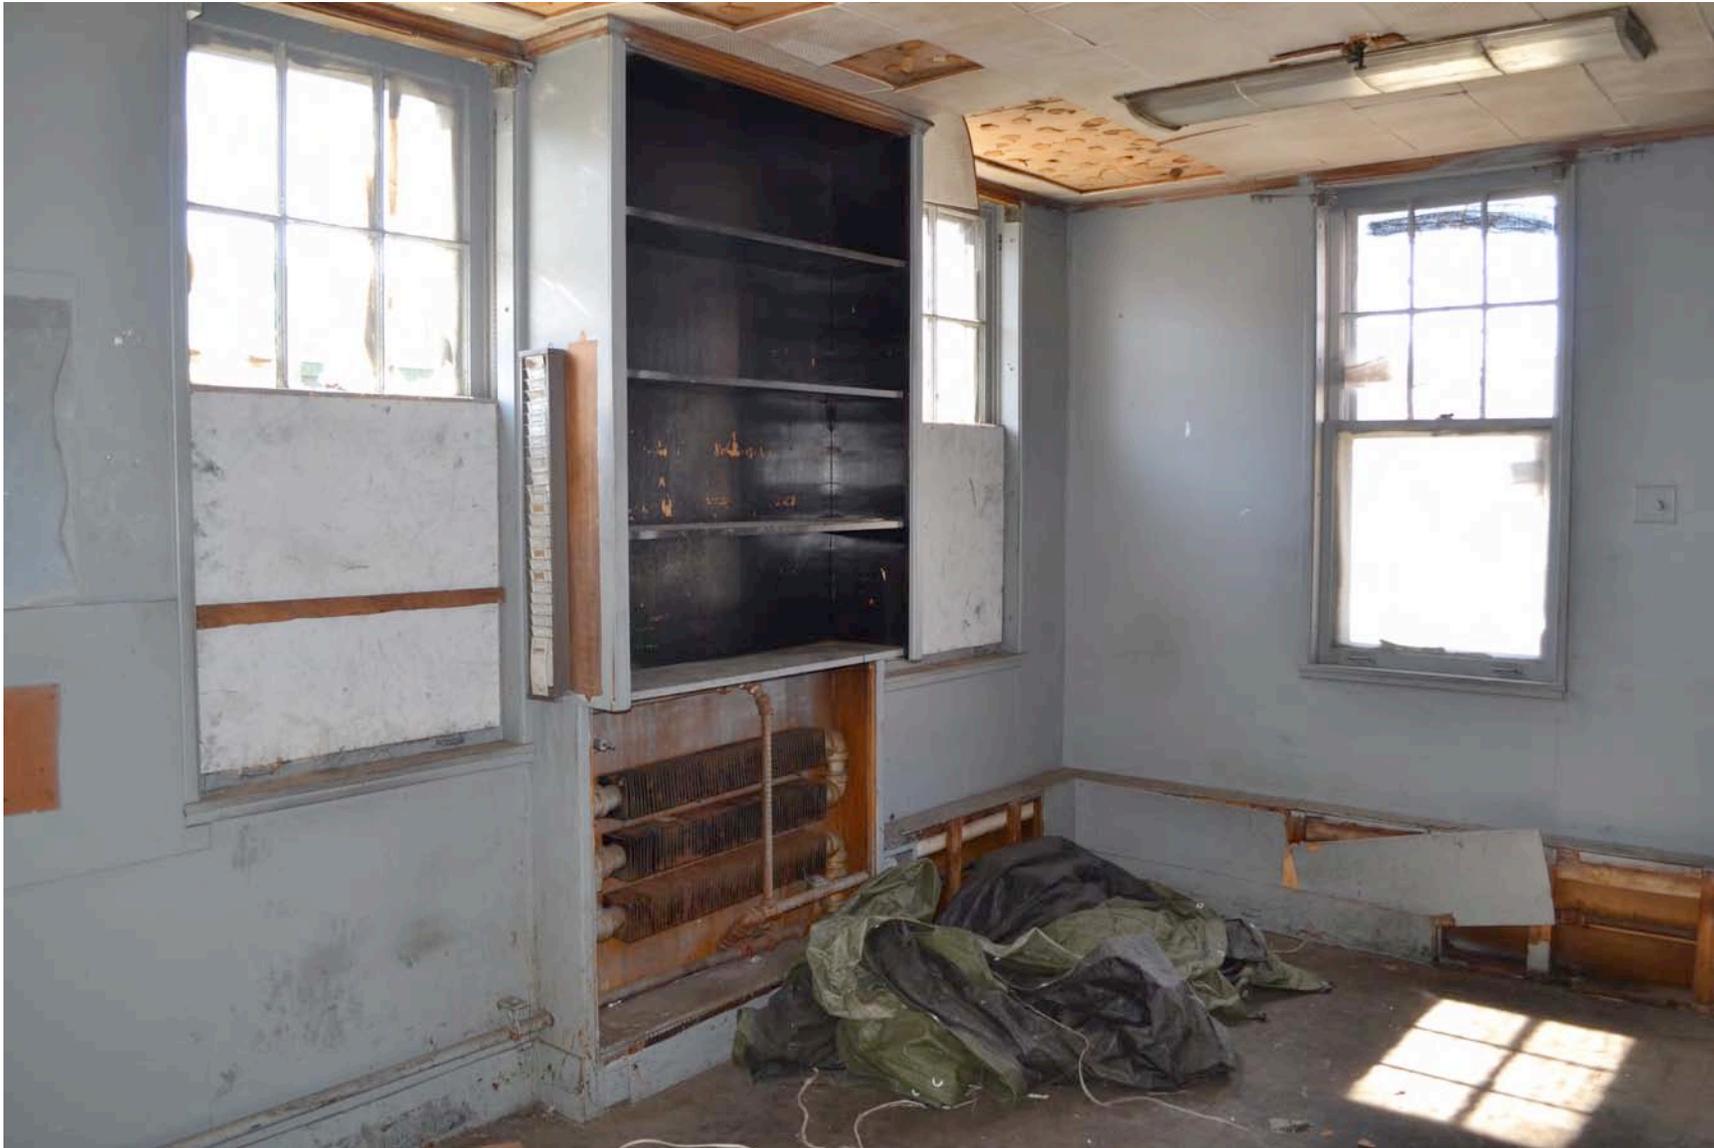
Interior of the Stanley P. Rockwell Company office/laboratory building. Note details of the southwest office. Camera facing southwest. Photograph 12 of 23.

The first floor of the office/laboratory building is a primarily open space with an asbestos tile floor, both exposed brick and plaster walls, and a fiberboard ceiling (Photograph 11). Two small offices and a storage closet are located at the southeast corner of the block near the entry vestibule. These have plaster walls and paneled wood doors with large lights in their upper halves. The office at the southwest corner of the block also has molded window trim, crown molding, and an acoustic tile ceiling (Photograph 12).

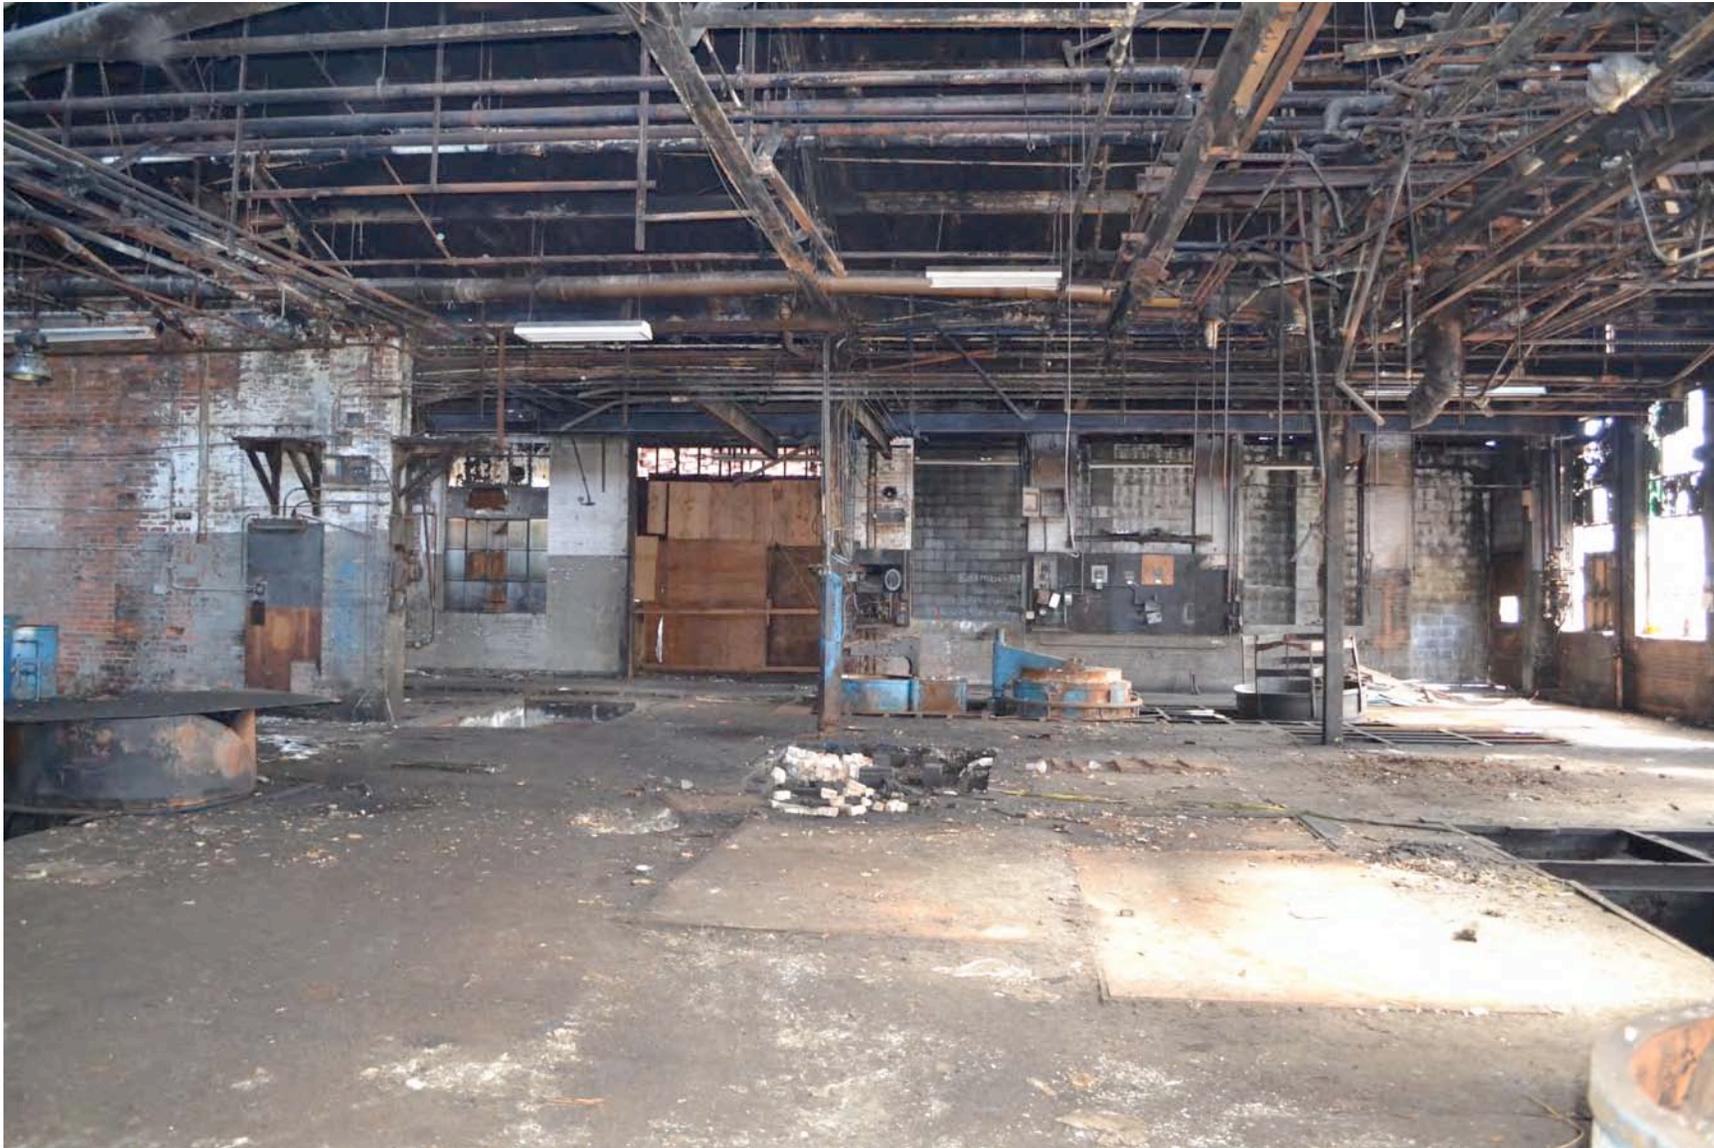
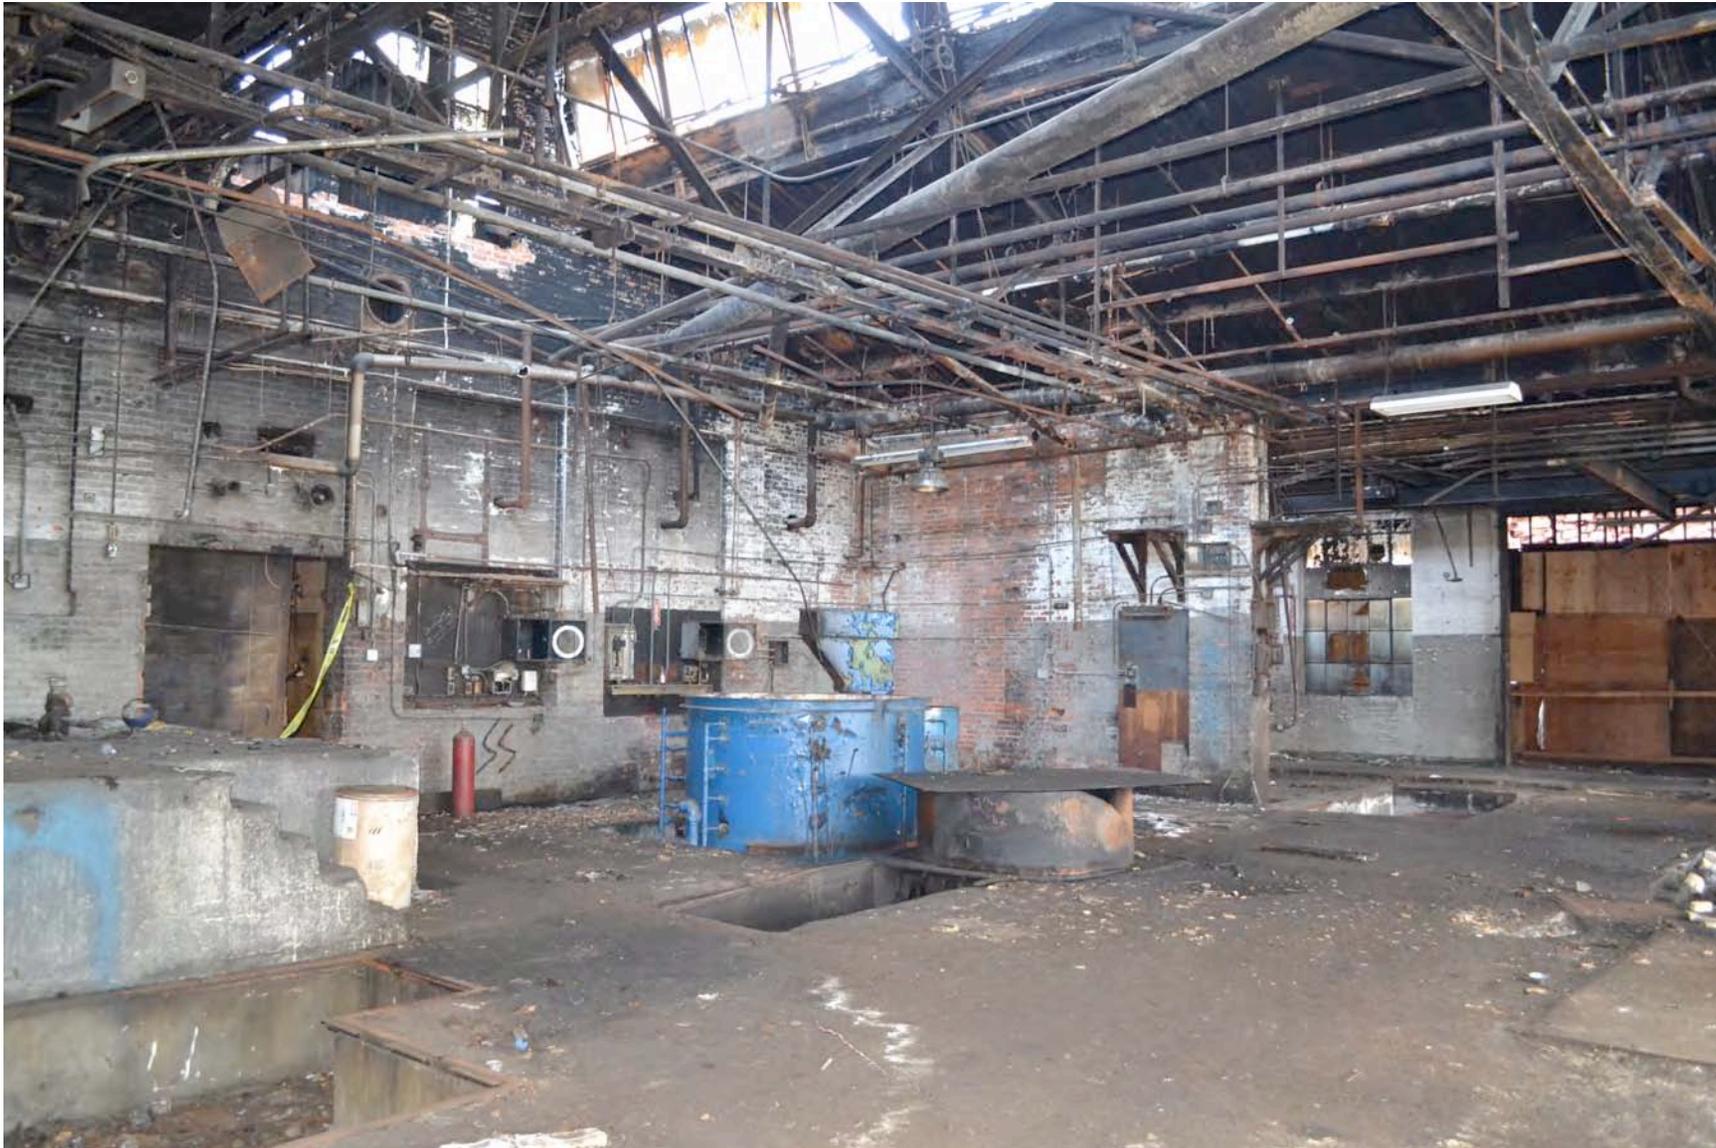
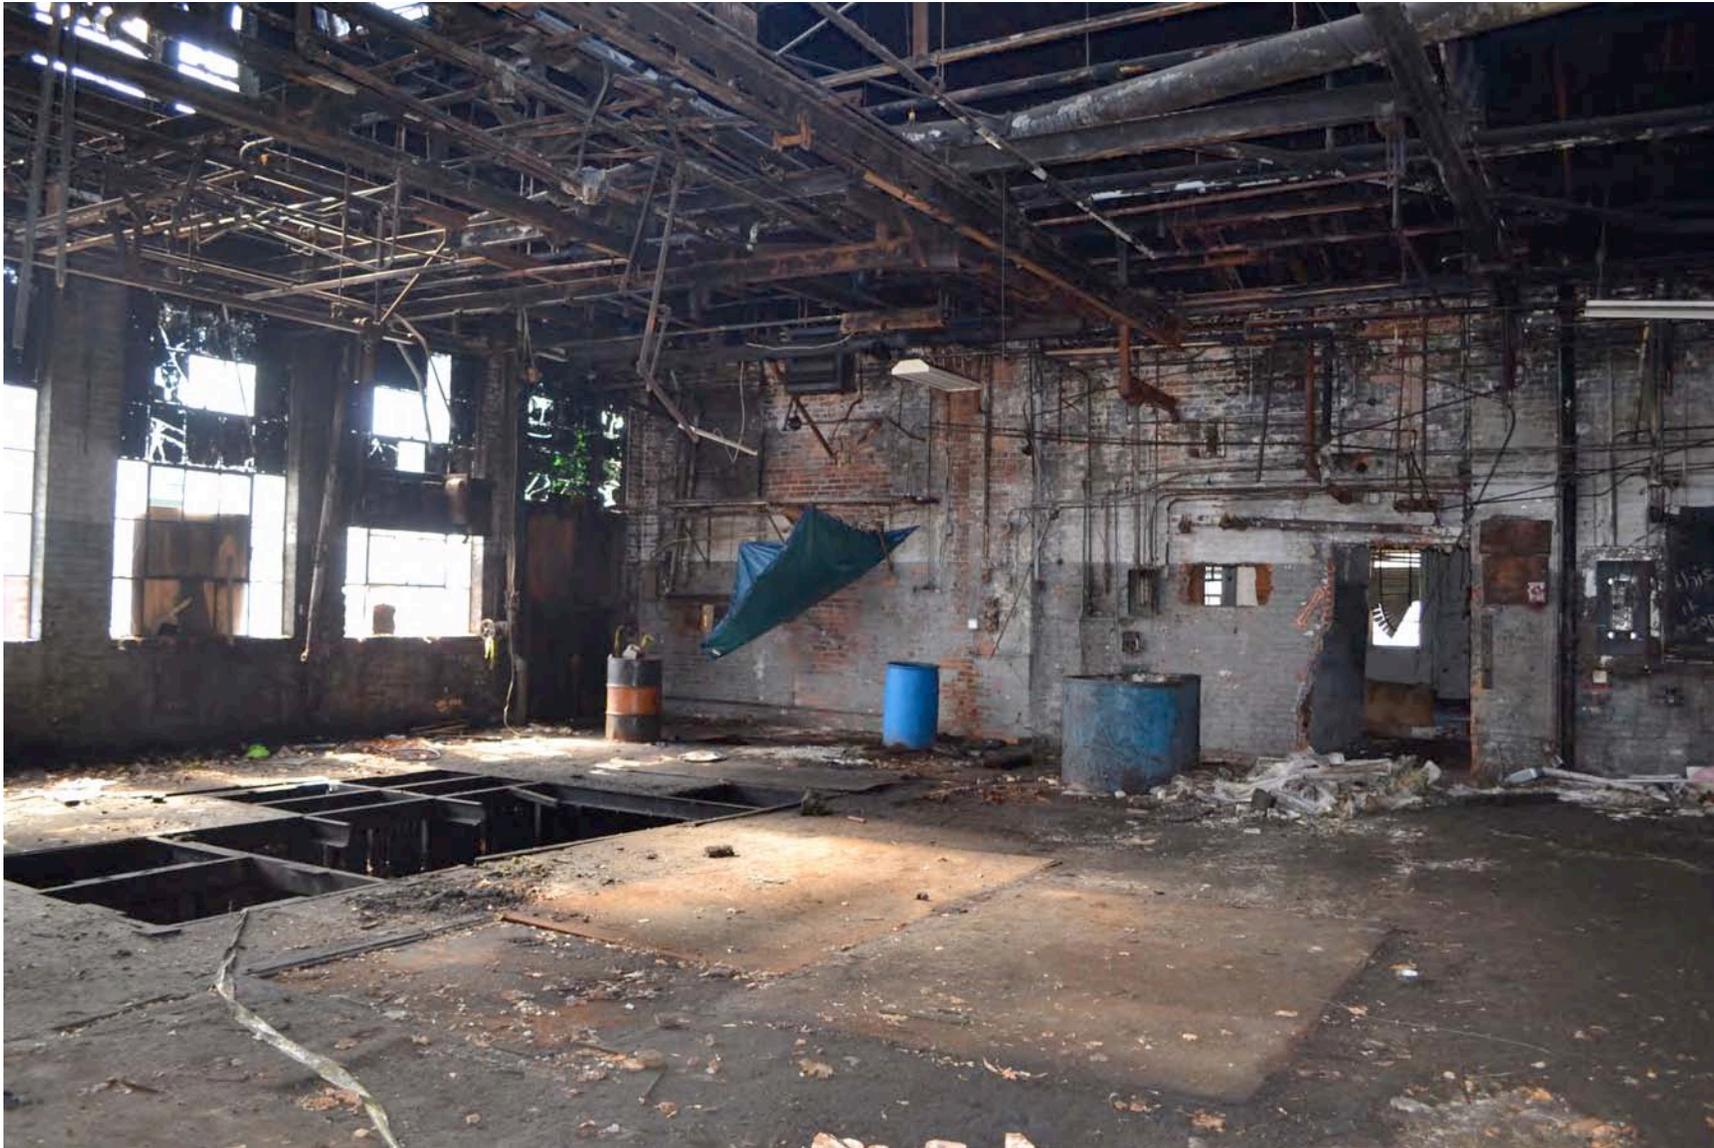
Interior of the Stanley P. Rockwell Company main manufacturing building. Note existing equipment and infrastructure throughout. Camera facing southeast. Photograph 13 of 23.

Interior of the Stanley P. Rockwell Company main manufacturing building. Note existing equipment and infrastructure throughout. Camera facing northeast. Photograph 14 of 23.

Interior of the Stanley P. Rockwell Company main manufacturing building. Note existing equipment and infrastructure throughout. Camera facing southwest. Photograph 15 of 23.

An opening in the east wall of the office/laboratory building leads into the main manufacturing block, this comprised of both the original shop and its 1943 addition (Photographs 13, 14, & 15). The block has an open floor plan that allowed for flexible use of the space. It has a concrete floor with various pits and footings for equipment (some of these still in place), red brick walls, and exposed iron trusswork supporting the roof. Dozens of iron pipes that formerly channeled water, gas, and chemicals throughout the plant crisscross the ceiling and the two full-length clerestory monitors provide the space with copious sunlight (Photograph 16). The roof has wood decking and the monitors have wire-glass fenestration with chain-operated openings.

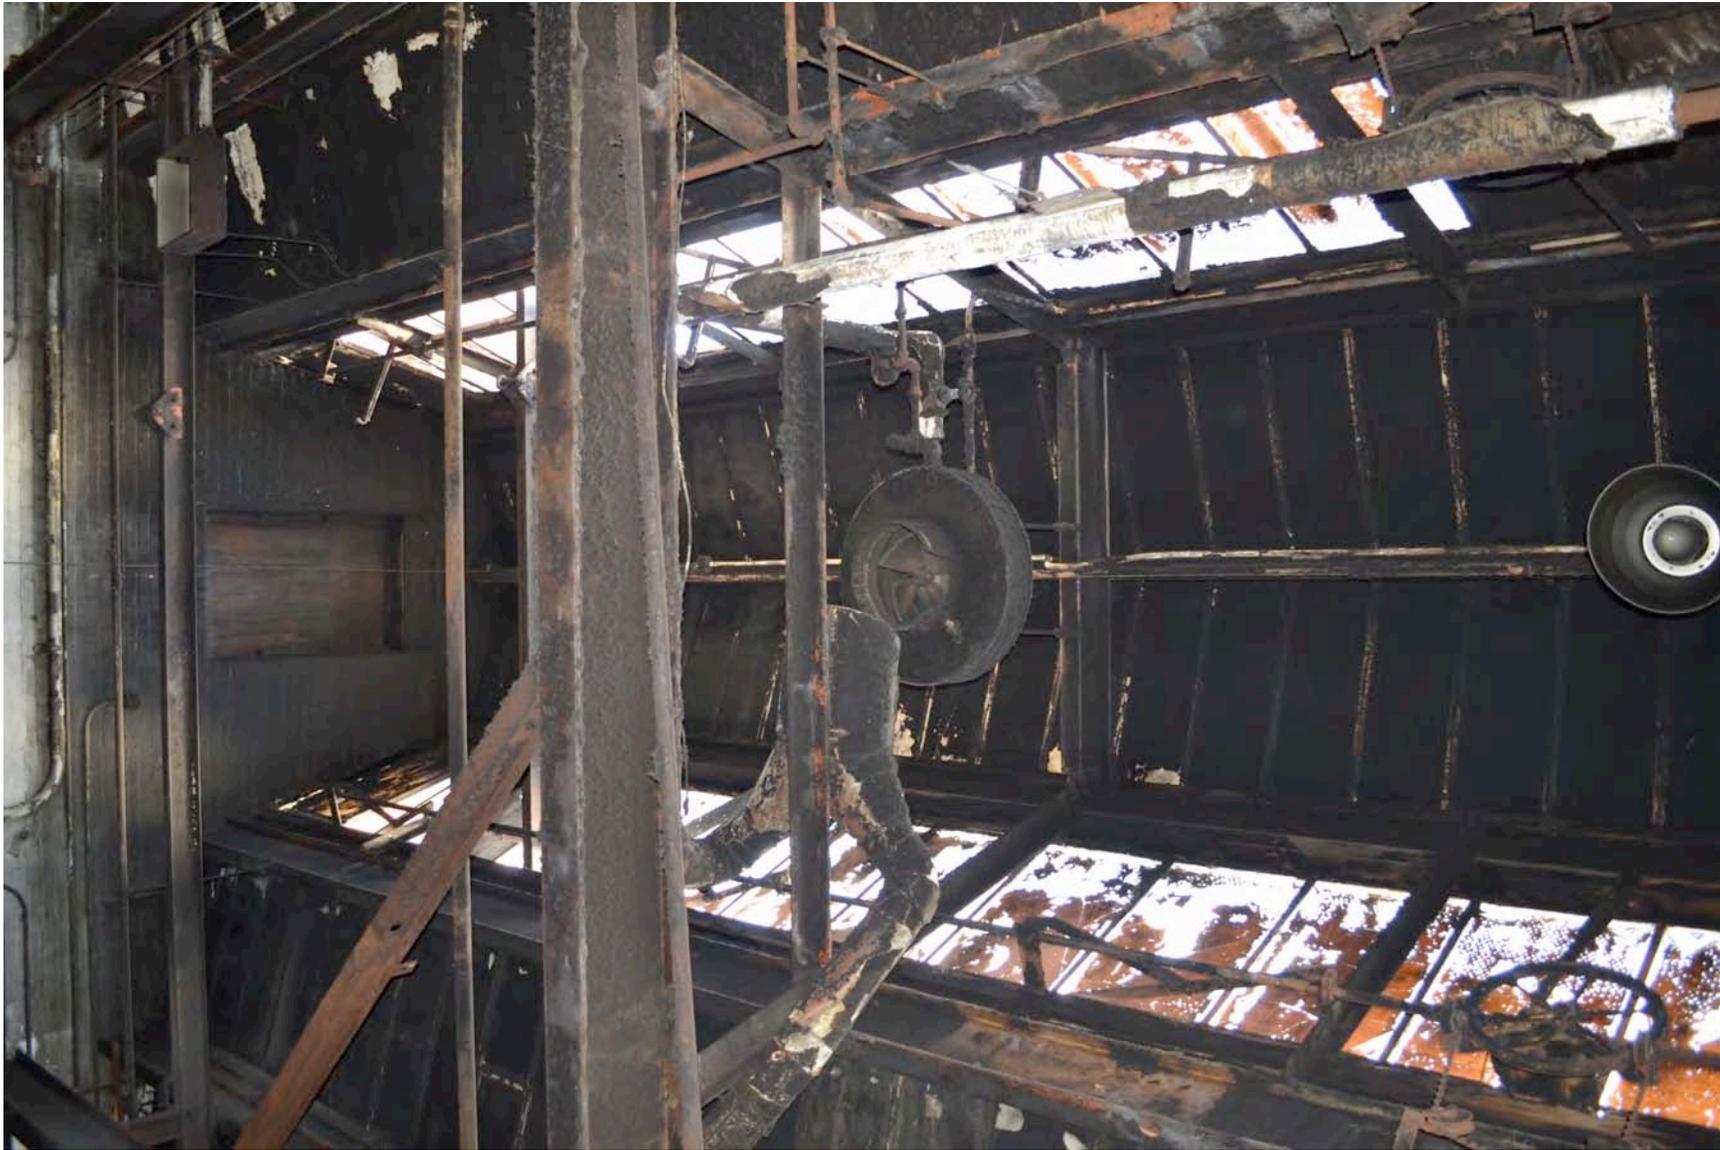
Interior of the Stanley P. Rockwell Company main manufacturing building. Note clerestory monitor details. Camera facing northeast. Photograph 16 of 23.

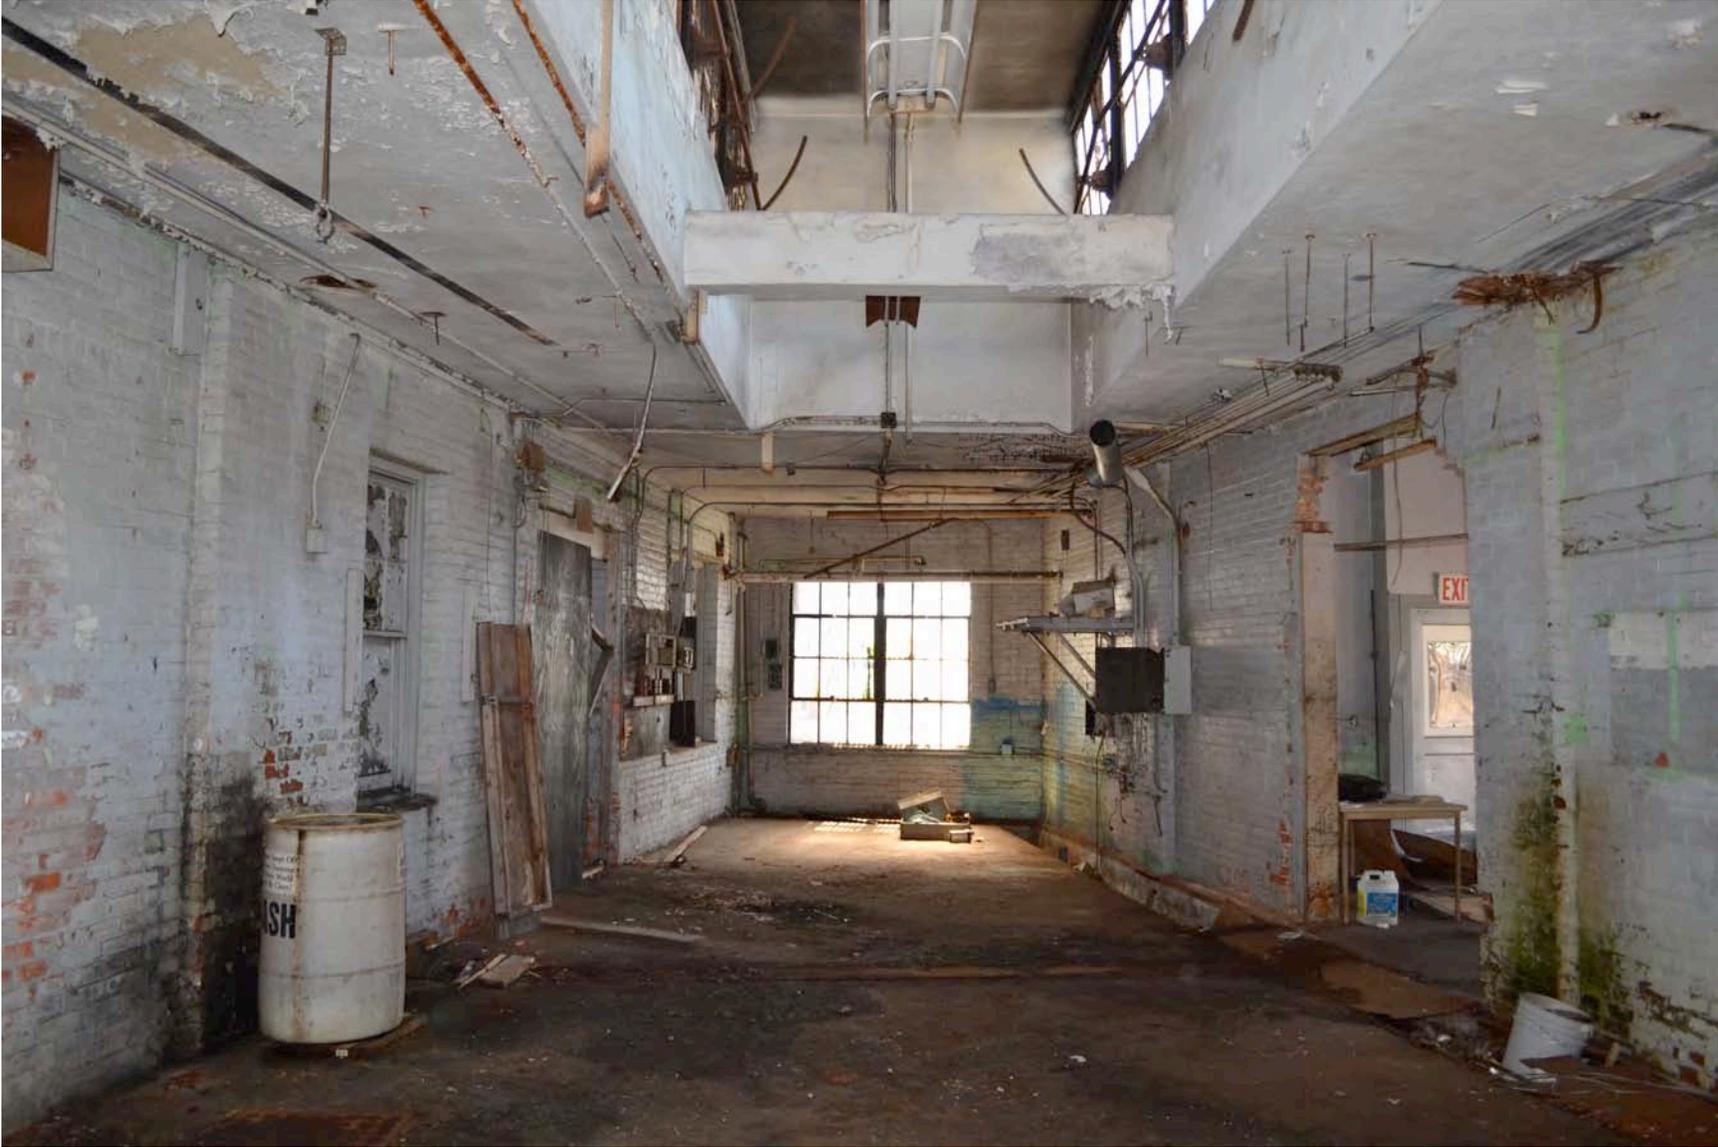
Interior of the Stanley P. Rockwell Company's east addition.
Camera facing southwest. Photograph 17 of 23.

An opening in the east elevation of the manufacturing block lead into adjoining addition. This has a concrete floor and both concrete block and wood-frame exterior walls (Photograph 17). The block consists of a single open space with an unfinished ceiling and walls.

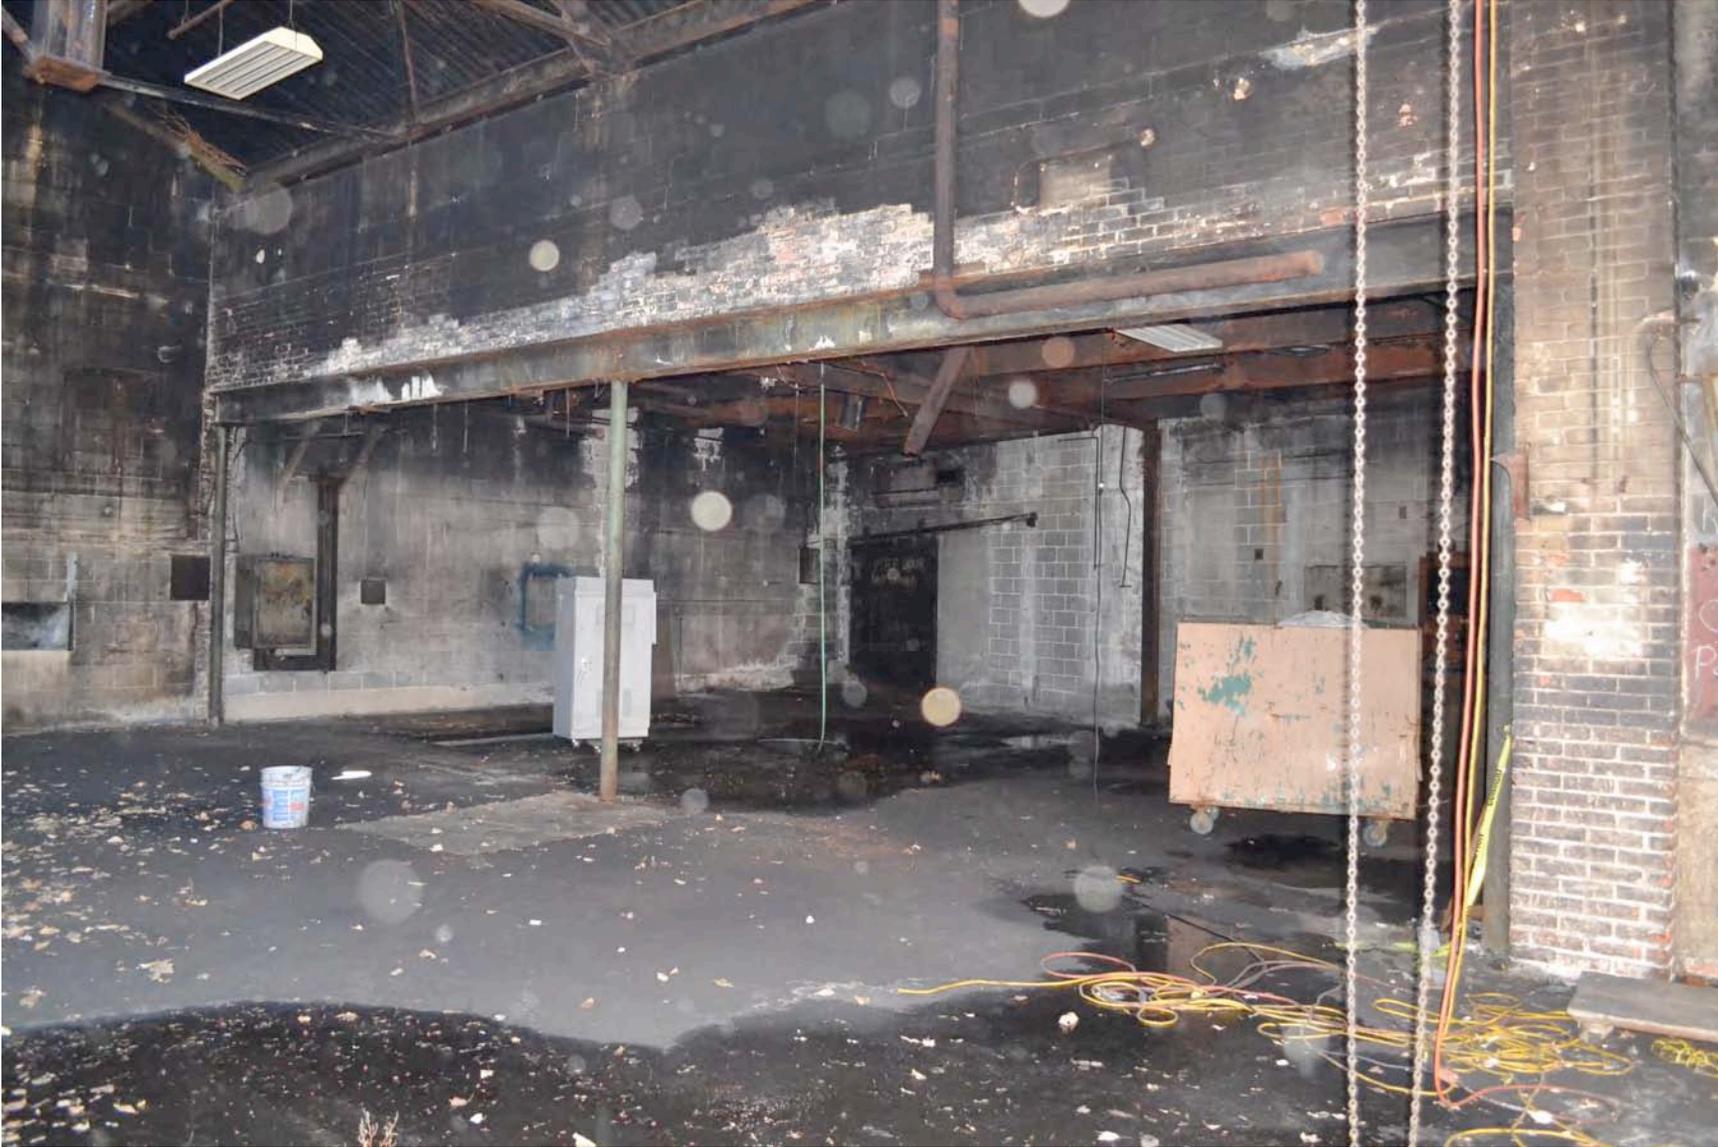
Interior of the Stanley P. Rockwell Company's shipping and storage addition.
Camera facing southwest. Photograph 18 of 23.

The shipping and storage block adjoins the west and north elevations of the office/laboratory building, however, the primary access between the two blocks consists of a large doorless opening on the west side of the office/laboratory building. The shipping and storage block has a concrete floor, exposed brick walls, and both plastered and unfinished ceilings (Photograph 18). A clerestory monitor with wire-glass fenestration is located above the western portion of the block.

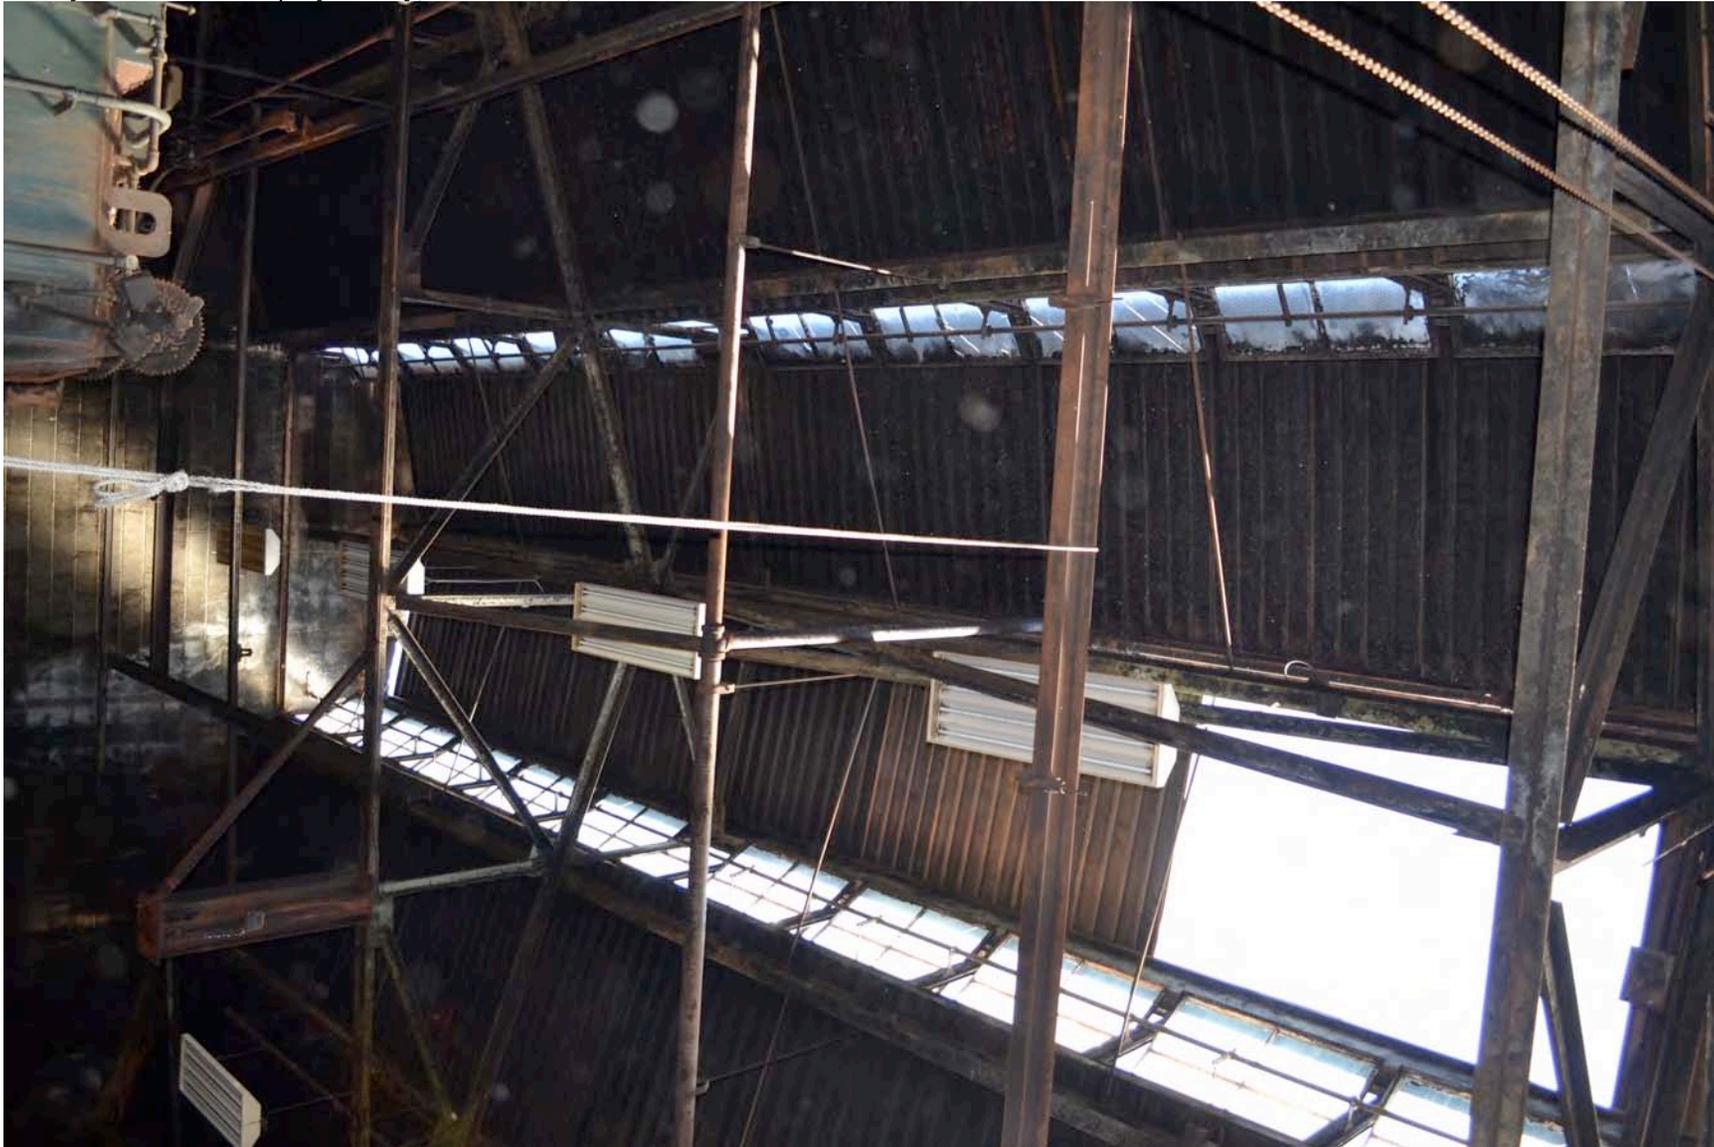
Interior of the Stanley P. Rockwell Company's northeast addition.
Camera facing east. Photograph 20 of 23.

The addition at the northeast corner of the factory can be accessed via the eastern end of the shipping and storage building or from two roll-up doors on the block's west elevation. The addition has an open floorplan with concrete floors, concrete block walls, and an unfinished ceiling with exposed iron trusses (Photograph 19). The roof has corrugated metal decking and a gabled clerestory monitor with chain operated, pivot-type, wire-glass fenestration (Photograph 20).
