CONNECTICUT STATE REGISTER OF HISTORIC PLACES REGISTRATION FORM

historic name Stanley P. Rockwell Company Factory
 other names/site number _____

street & number 296 Homestead Avenue
 city or town Hartford vicinity
 county Hartford zip code 06112 not for publication

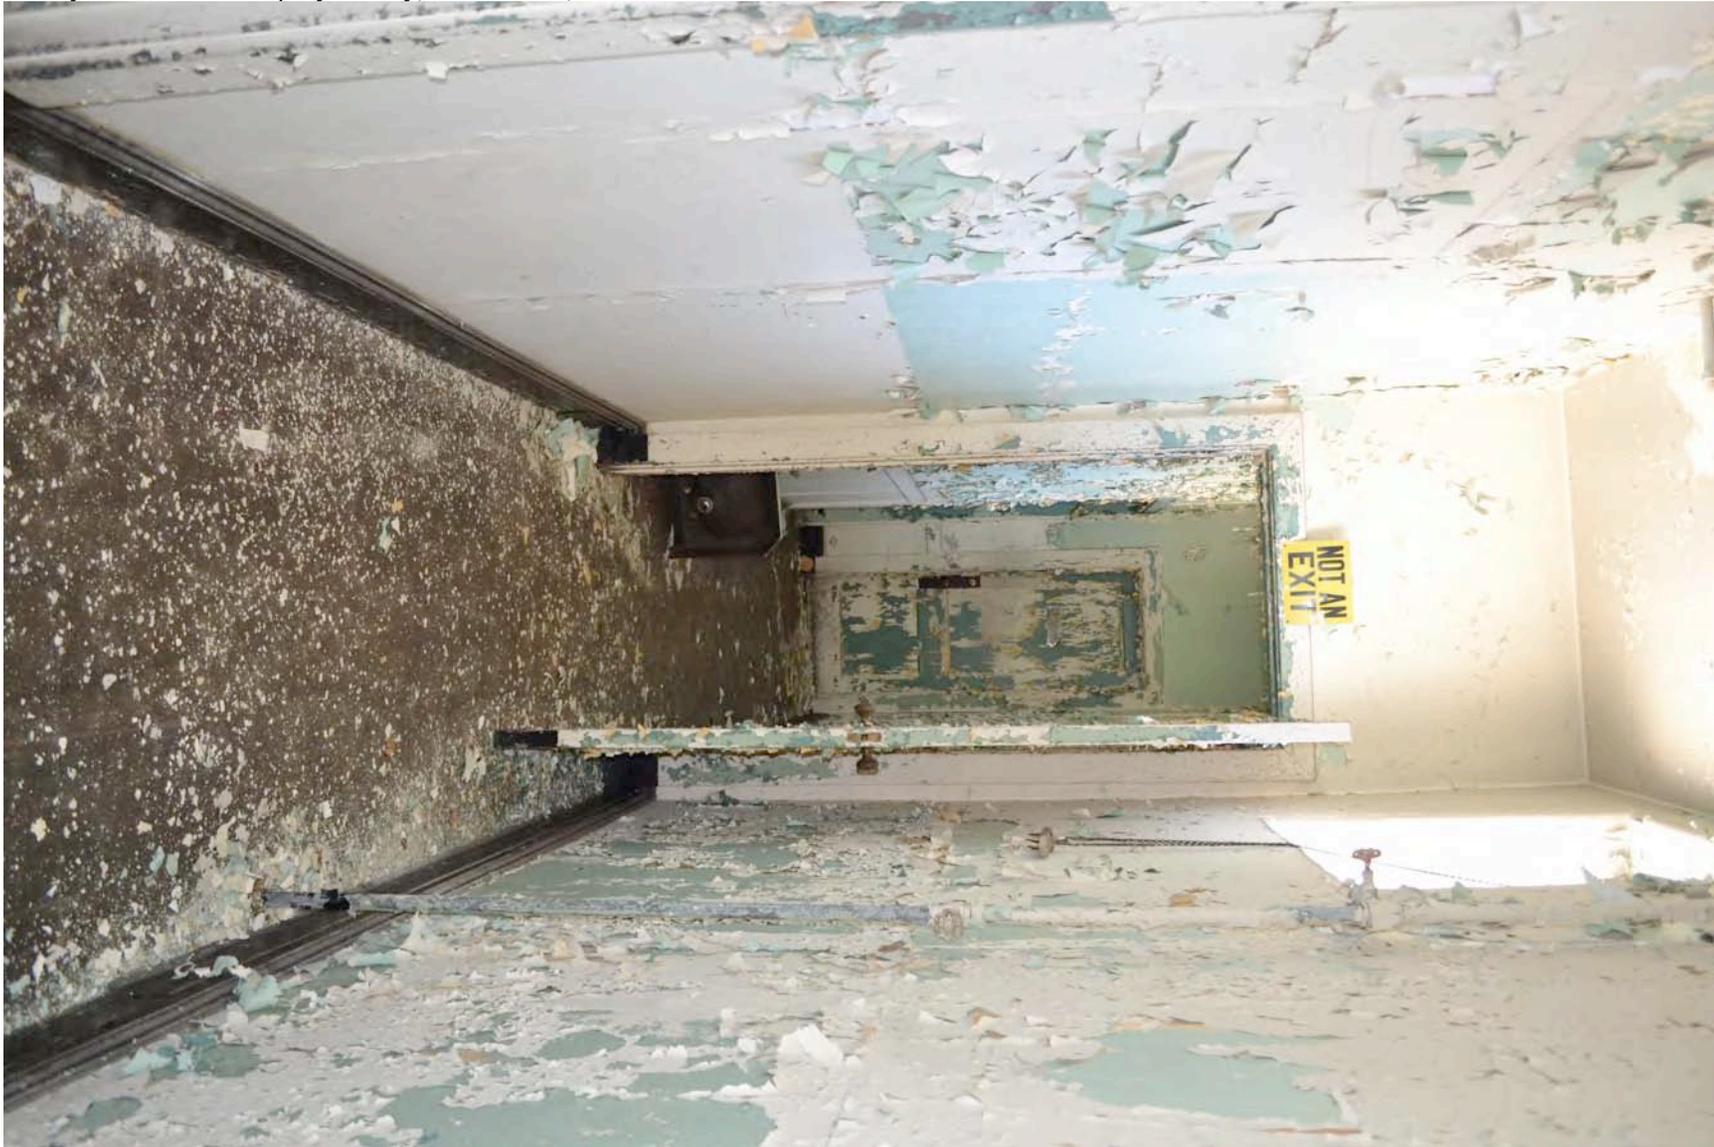
Interior of the Stanley P. Rockwell Company's northeast addition.
Camera facing east. Photograph 20 of 23.

The addition at the northeast corner of the factory can be accessed via the eastern end of the shipping and storage building or from two roll-up doors on the block's west elevation. The addition has an open floorplan with concrete floors, concrete block walls, and an unfinished ceiling with exposed iron trusses (Photograph 19). The roof has corrugated metal decking and a gabled clerestory monitor with chain operated, pivot-type, wire-glass fenestration (Photograph 20).

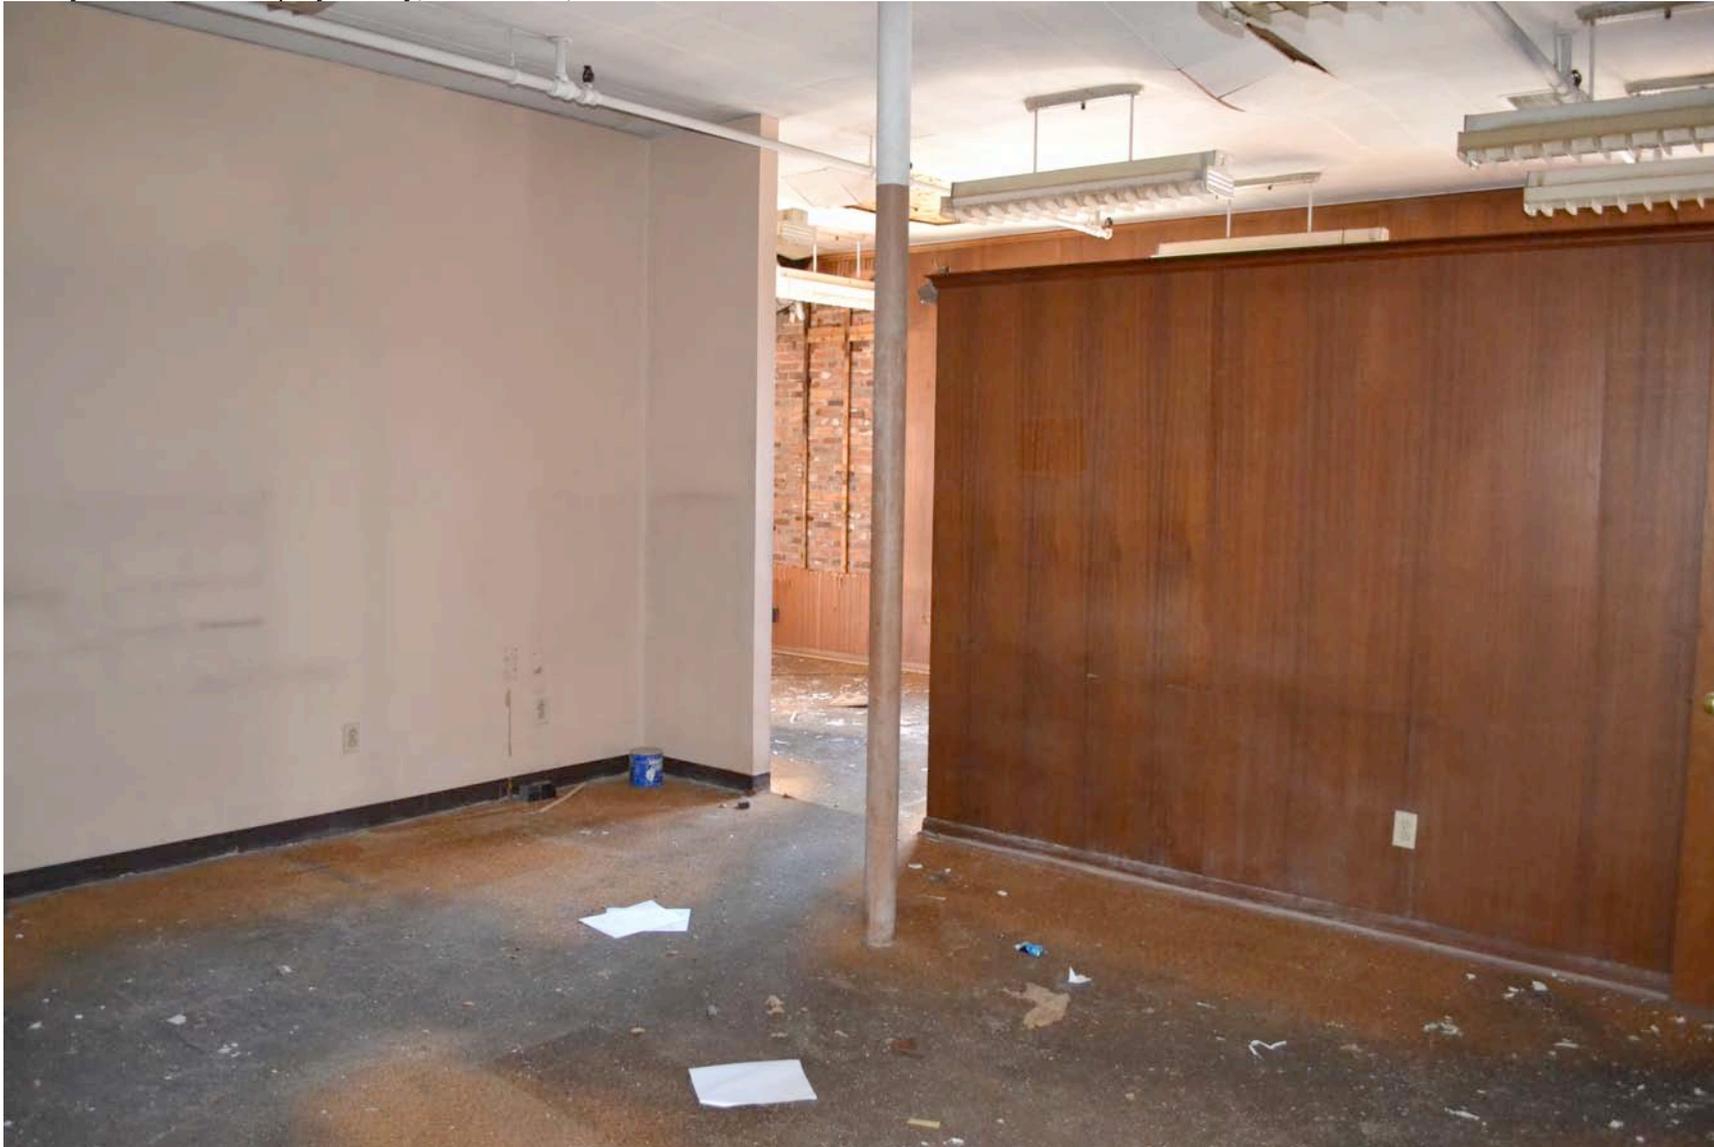
Interior of the Stanley P. Rockwell Company's office and laboratory block, second floor.
Camera facing north. Photograph 21 of 23.

The second floor of the factory's office and laboratory building can be reached by the staircase in the main entry vestibule or via a metal fire escape on the west side of the block. The interior staircase leads to a narrow corridor that runs along the building's east elevation (Photograph 21). The corridor has an asbestos tile floor, molded mopboards, plaster walls and ceilings, plain wood door trim, and paneled wood doors. It leads to two lavatories at the northern end of the corridor, while several small offices flank the west side of the corridor. The offices have carpeted floors, wood paneled or sheetrock walls, and acoustic tile ceilings (Photograph 22 & 23).

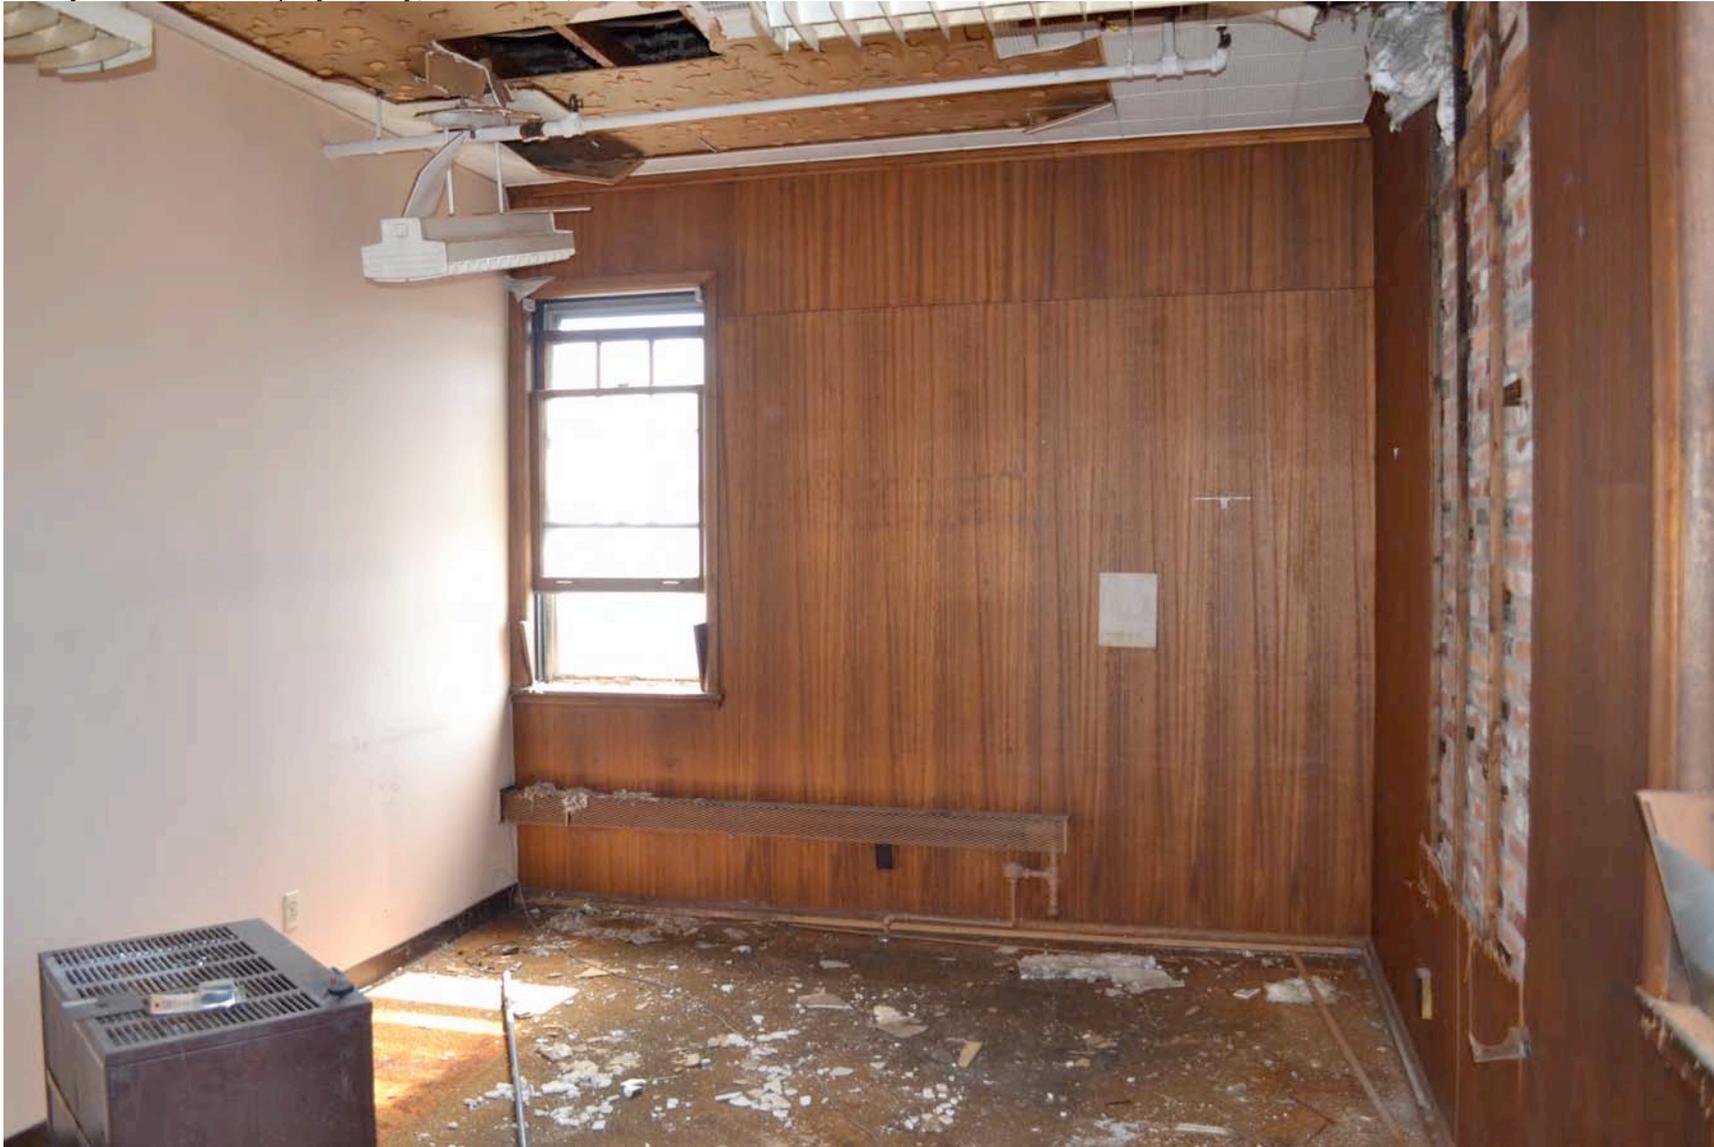
**Interior of the Stanley P. Rockwell Company's office and laboratory block, second floor.
Camera facing southwest. Photograph 22 of 23.**
